Seismic Strengthening and Restoration of Cargill's Monument

Bevan White¹, Geoff Anderson² and Jerry Kearney³

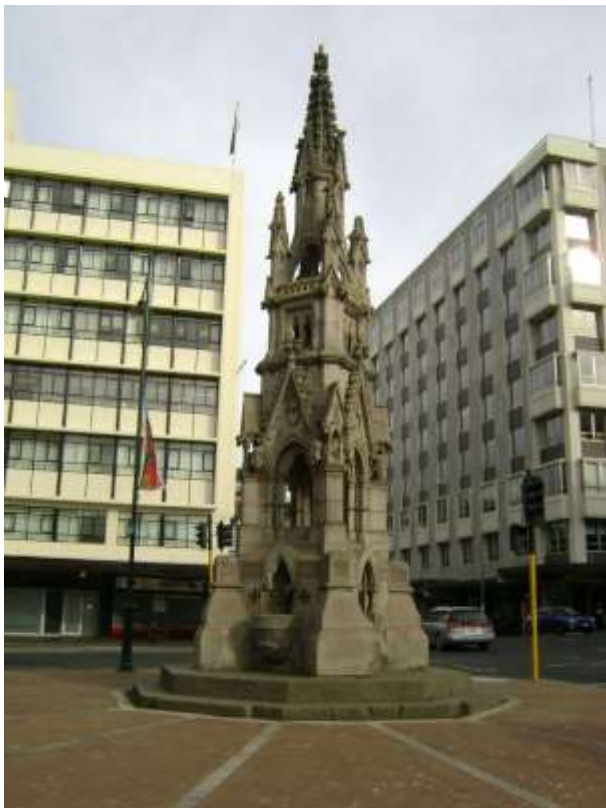
Initially this project started off as a maintenance and refurbishment project, as some of the stone elements had become loose or had fallen off due to weather erosion, vandalism and inappropriate maintenance (such as abrasive cleaning). Some stonework was also showing cracks and movement in and around the joints.

Figure 3: Cargill's Monument before restoration.

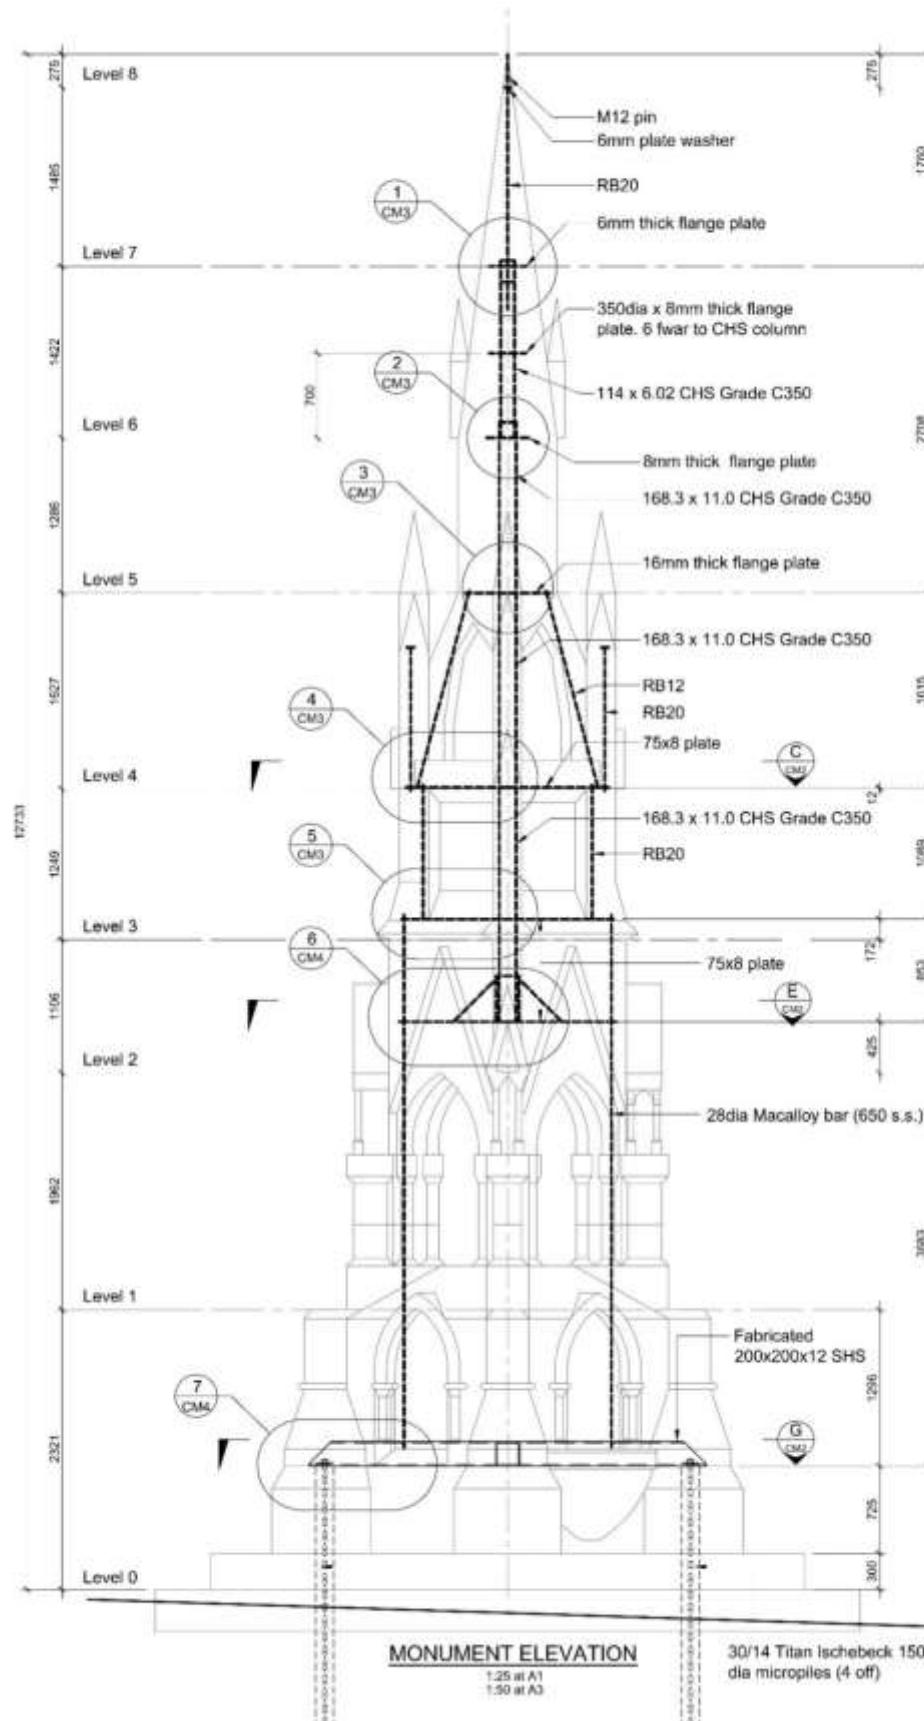
Figure 6: Seismic strengthening frame model.

The monument's structure was analysed using Microstran computer analysis software to determine the expected design forces within each of the structural elements. This was conducted by modelling a frame structure that consisted of equivalent sized concrete members replicating the stone dimensions and properties in conjunction with the new central steel tie elements [Figure 6]. The analysis used the equivalent static method with the forces applied at the six levels throughout the monument where diaphragm action was expected to occur with the installation of the new steel plate members.

The tensile forces are transferred through the structure by the installation of the vertical steel tie members located within holes cored through the stone elements, with each of these tension ties restrained at the various levels by the cross braced plates. The tension ties were introduced throughout the height of the monument to provide a continuous load path within the stone all the way down to the base of the structure.

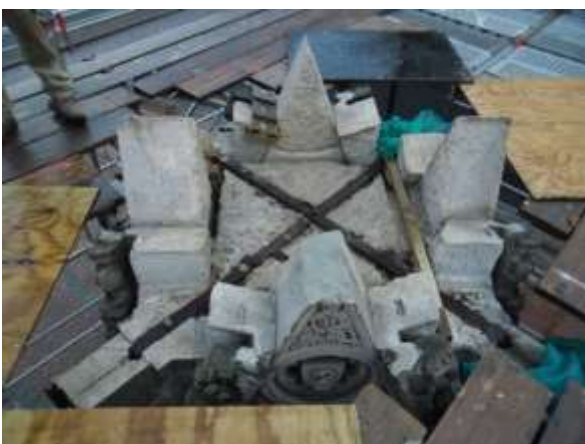
The Wainwright report [6] identified damage to stonework from abrasive cleaning and from water ingress through the joints, causing the original metal ties to corrode causing further damage especially around the upper flying buttresses and lower vault arches. The Williams report [7] made recommendations for repair and restoration works which included the systematic deconstruction of the upper part of the monument to enable removal of the faulted steel armature and damaged stones. It also revealed several archaeological features in the immediate vicinity of the structure, which needed to be considered if the ground was to be disturbed. In the event of disturbance below the monument it was possible that evidence of earlier subterranean public toilets (said to have been filled in with sand and broken toilets), remains of the former Mechanics' Institute, and pre-1900 use of the site by both Europeans and Maori, could be encountered.

Figure 7: Dismantling revealing original corroded tie bars.

The restoration part of the project required removal of the original steel cross ties that had varying states of corrosion and replacing these with highly protected metal (Thermal zinc spray and a high build epoxy coating).

The monument was carefully dismantled in late 2011 to a low level just above the lower arches, removing all corroding steel. [Figure 7]. The stone elements removed were transported to a workshop for repair and for coring vertical holes to fit proposed rods.

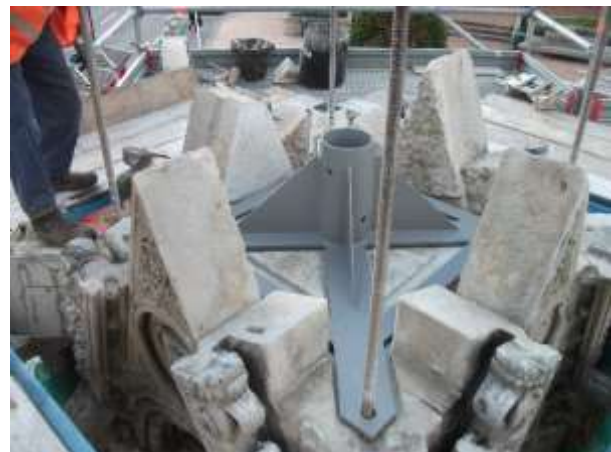
Figure 8: Reconstruction.

Above the lower arch there was sufficient internal void to enable a central steel column to provide lateral restraint from plates and rods at various levels [Figures 8 and 9].

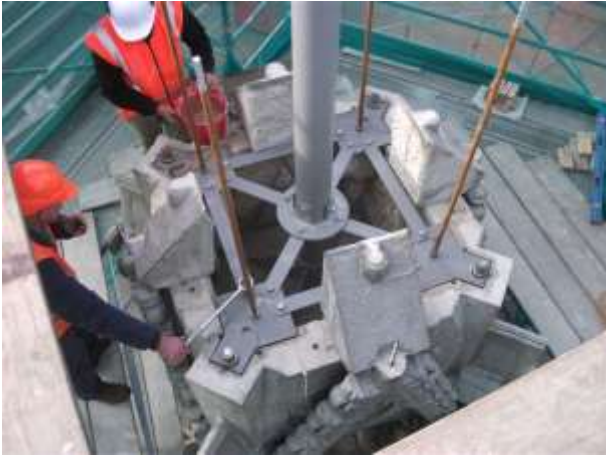
Figure 9: Re-Construction plates and rods.

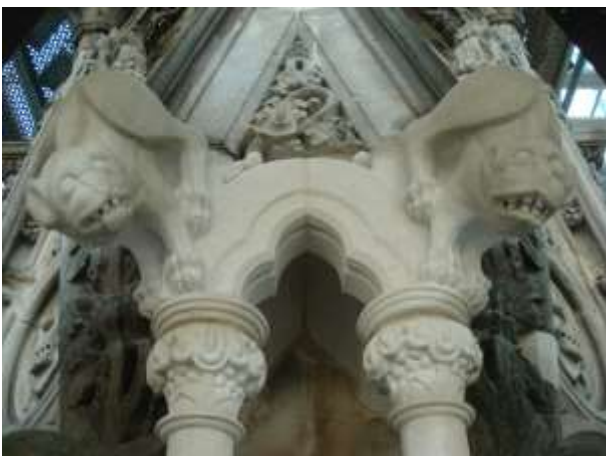
Figure 10: New carved stone Grotesques.

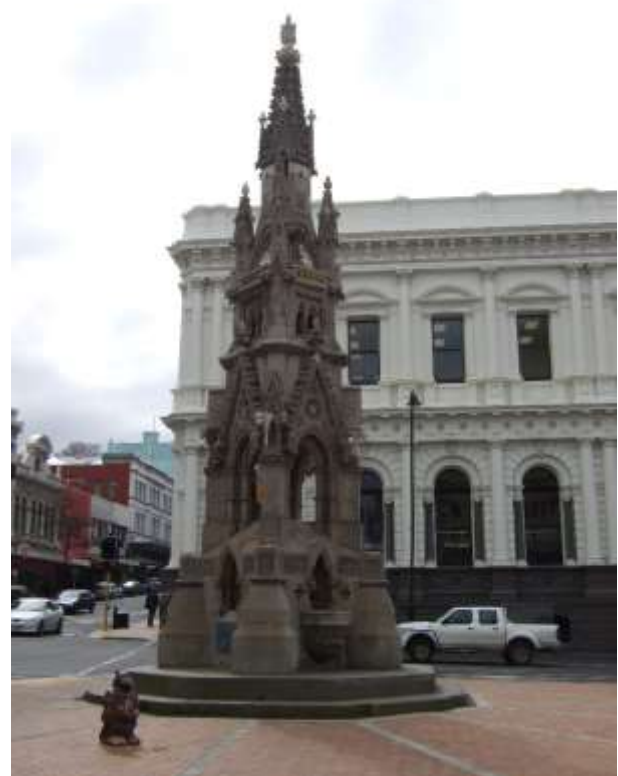
Figure 11: Restored and Strengthened Monument.
