# *3<sup>rd</sup> Australasian Engineering Heritage Conference 2009*

## **Port Craig Viaducts Engineering Assessment and Conservation Plan**

Trevor Butler, BE(Hons); MBA(Exec), CPEng(Civil,Struct), Director Frame Group Ltd

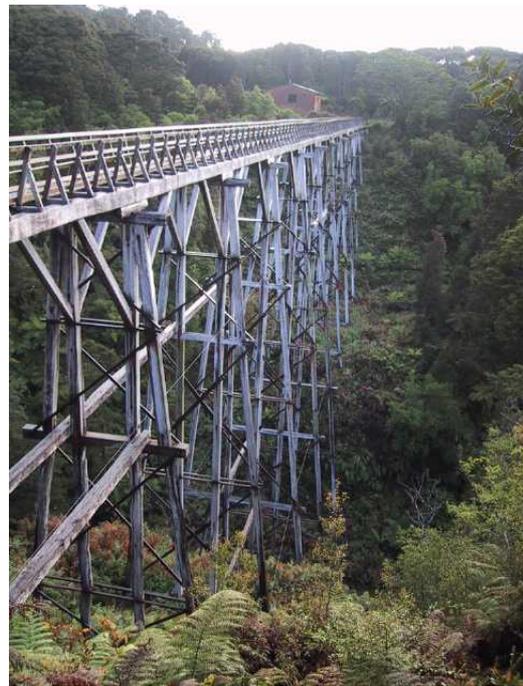
*Figure 2. Current appearance of Percy Burn Viaduct*

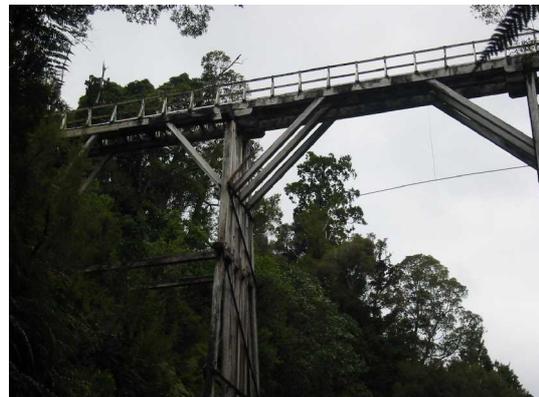
*Figure 3. The longer central span of the Edwin Burn Viaduct*

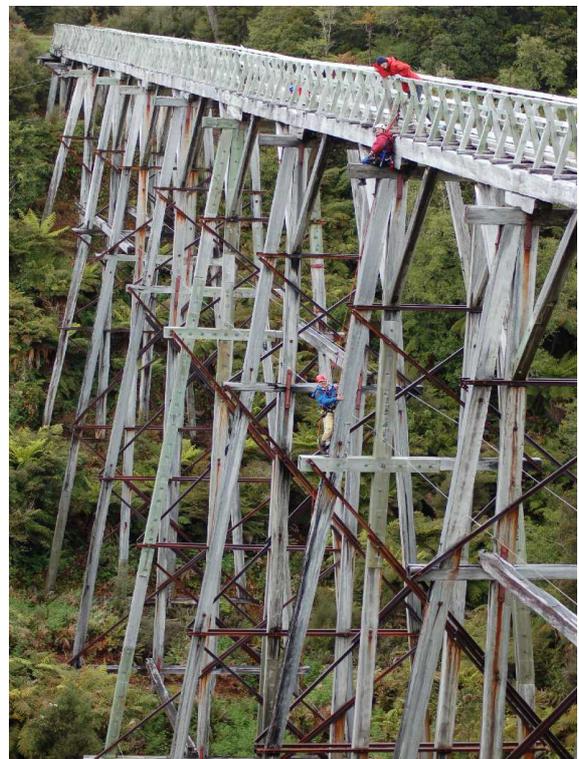
*Figure 4. Close inspection of Percy Burn Viaduct piers*

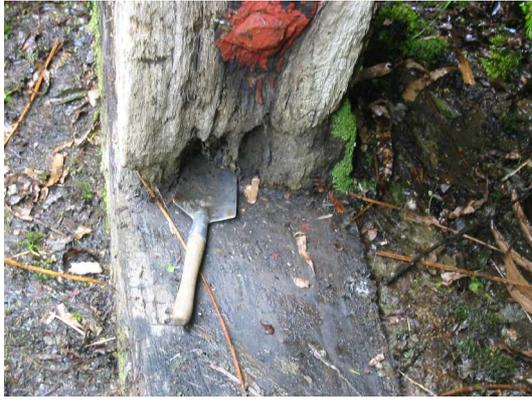
- End Rot: Fungal rot enters hardwood timbers along the more permeable longitudinal grain from exposed ends. Several pier caps suffer from this, however good construction detailing in most places (except the horizontal pier bracing) has minimised the structural impact of this effect.

**Figure 5.** End rot at the ends of pier columns

- Internal rot treatment: Where internal cavities are accessible, treatment with preservative foam is recommended, however access to most internal cavities in the viaduct timber is extremely difficult. Insertion of boron paste into bored holes at the ends of timber members is recommended. This is more suitable for dry timber and diffuses more readily through timber than copper naphthenate.

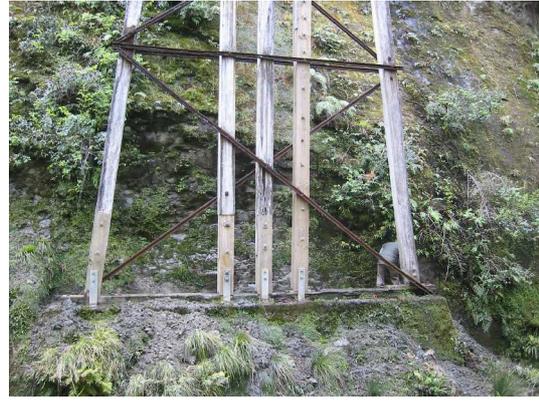
**Figure 6.** Previously repaired pier columns with laminated spliced timber

- Lamination: Removal of rotted portions of original hardwood timbers and replacement of these with spliced laminates. The 1994 and 1999 work included this type of work and it has been highly effective in maintaining structural integrity and was achieved at reasonable cost. Whilst this approach has provided a structurally successful solution which assimilates the original structural form of the viaducts, the appearance of large numbers of bolted and spliced timbers detracts from the clean simple original appearance. There is a concern that if this approach is continued, the viaducts would take on the appearance of “giant lego”. For this reason, continuation of pinus radiata splicing is regarded as an option that should be pursued only if more visually acceptable options cannot be adopted.
