The four R's – Reduce Risk, Raise Resilience: Local authority priorities and the Auckland perspective on engineering requirements for heritage buildings

Abstract

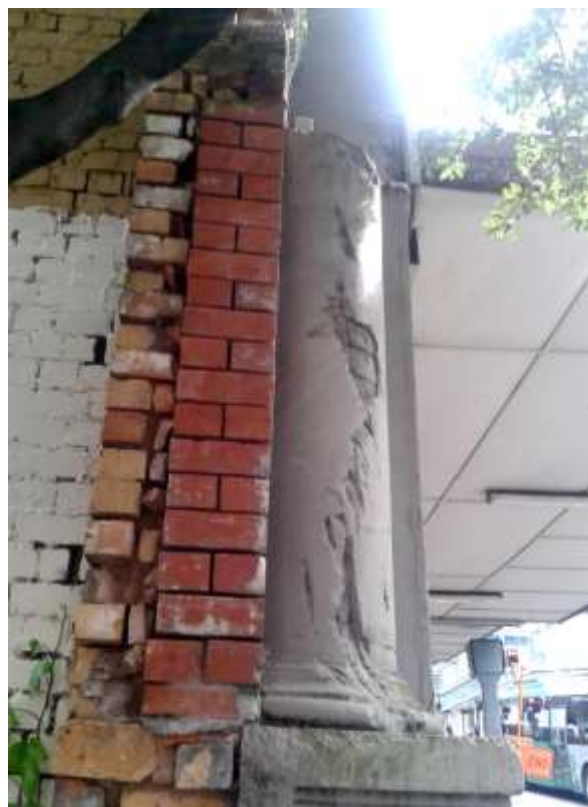
Figure 3: Wellesley Street, Auckland; example of typical cross-section of an Edwardian URM building. Note the irregular coursing and variable mortar joints resulting from use of facing bricks (19 courses to top of column) and commons (20 courses to top of column) behind.

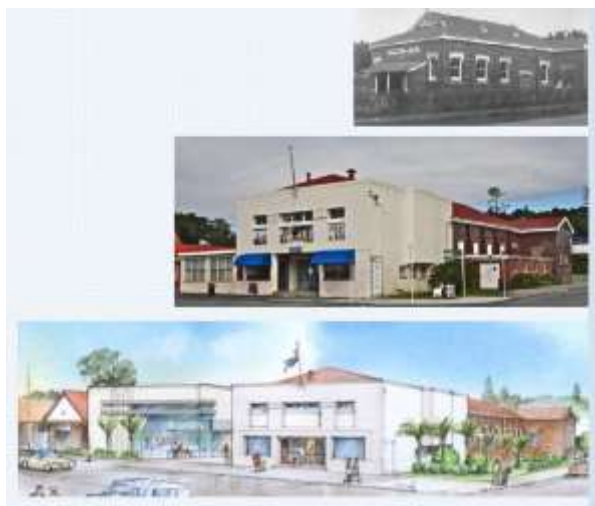
Figure 10: Warkworth Town Hall; past, present and possible future iterations

Warkworth Town Hall was originally constructed in 1909, using a system of hollow, salt-glazed ceramic bricks patented by the Clark Brickworks, Hobsonville. The block was a large hollow rectangular brick with a vertical divider and was the precursor to the modern concrete block technology. This construction form is locally, regionally and nationally rare, with only four known buildings surviving regionally; the other three are all related to the former Clark works. Following the First World War, the hall was extended and internally altered in the 'Art Deco' style. Subsequent additions in the latter half of the 20th century created unsympathetic **additions**. The building is registered as a Category A building in the District Plan, and is also on the New Zealand Heritage List as a Category 1 historic place, largely because of its technological construction and its historical context.

The hall was assessed by the former Rodney Council in 2005 for seismic performance and found to be earthquake prone. Following amalgamation it was subsequently closed in 2011 after structural issues were identified. Public consultation was undertaken to determine its fate. The process was not without contention, as not all members of the community were keen to retain the building. What came through strongly in the end, however, was a community desire to recognise its own bonds through its built heritage. As one online commentator stated:

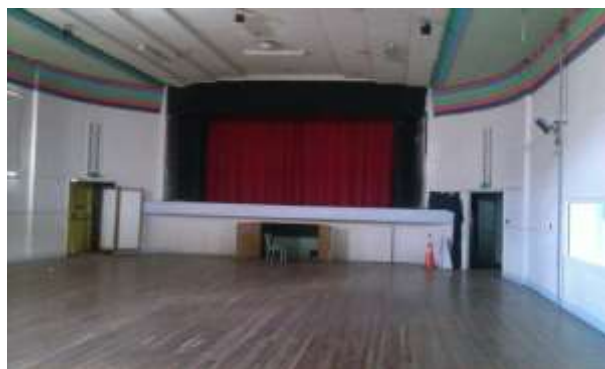
Figure 11: Non-fire rated Art deco interior alteration of main hall

Ultimately it was decided to keep the hall, and Art Deco extension, which also has heritage significance. The later accretions are to be removed in a phased programme of work, with a new extension and remodelling of the upper floor to accommodate a lift and link to the new extension. The overall budget for the first phase of development, including the new build extension, was \$3 million. The role of the Rodney Local Board was critical in securing funds for the first phase, and leading the support for fundraising to meet the targets for the future planned phases of work.
