Research Before Restoration

William Cottrell¹

¹ University of Canterbury, Christchurch, New Zealand; cottrellone@gmail.com

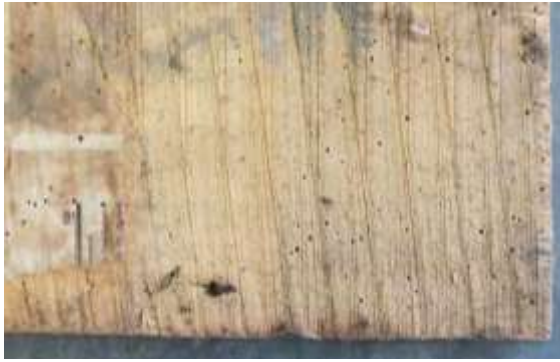
Figure 1: Reciprocating saw marks, c.1852.

By working backwards from a few fragments we are forced to consider deeply every detail. In 2012 an archaeologist asked me to remark on what I could determine from an old house's wall board [Figure 1]. In this situation I ask for no other

I could tell that it was New Zealand native white pine or kahikatea because of the colour and extensive worm damage. This was a species used by the first European colonists before they realised its poor durability. Also, it is a species more often found at low altitudes, particularly in coastal regions, colder climates and in or near wetlands. In lower areas it sometimes predominated over more durable and attractive timbers. The saw marks, or kerfs, were most unusually from a reciprocating saw. These were rare in New Zealand, early and generally powered by water-wheel. There was one completely hand-made nail still in the short section of board. This type of nail is virtually never found in the colonial context and would not be found after the 1850s.

We have some good information. A species used by the earliest settlers, generally in the 1840s and a nail type that would also agree with that decade. There were saw marks that indicate an early and uncommon water powered saw, probably situated on a stream or river near the sea for transport, and a timber species possibly found in a coastal region typical of where first settlement occurred. The board in fact came from an historic cottage, "Tui's Nest", in Port Lyttelton. [Figure 2]. The house, built about 1853, was owned by John Parsons who captained immigrant ships to Otago and Canterbury after 1848. Totara and kahikatea were the two dominant species on Banks Peninsula and John Pavitt had established a reciprocating saw mill around 1852 in nearby Robinsons Bay. Tui's Nest was demolished in 2012.

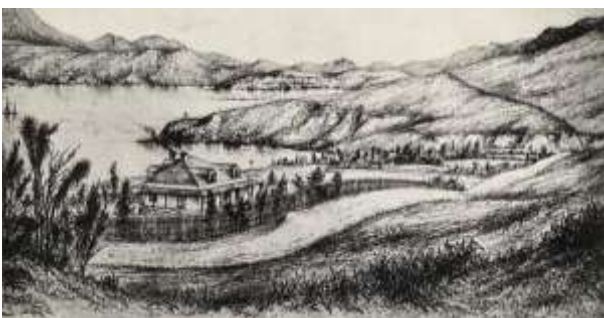
Figure 2: Tui's Nest, Lyttelton, c.1853.

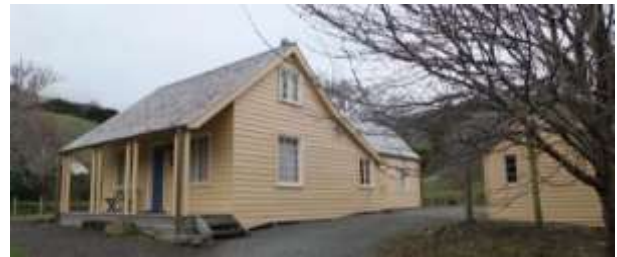
Figure 3: Pavitt Cottage showing older front part built c.1856-8 and newer rear wing from 1865.

A survey of the second surviving Pavitt Cottage [Figure 3] indicated a change of saw type. The first reciprocating mill had burnt down about 1854 and a new circular saw mill was subsequently built. The oldest front part to Pavitt's house showed all framing was of low-grade circular-sawn totara or kahikatea, consistent with it having been built after the completion of the second mill. This was extremely helpful in dating Pavitt's house since no surviving records indicated when the property was built. Further investigation showed that all timber had been hand dressed and moulded with traditional profiled planes [Figures 4]. The later rear wing, built in 1865, had machine profiled tongue and groove wall linings. This gave an end date to when the building must have been completed.

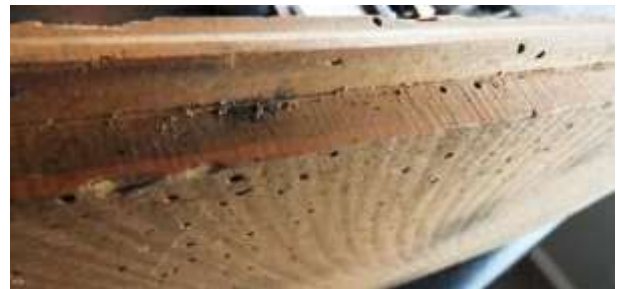
Figure 4.1: Kahikatea circular sawn board with hand planed tongue.

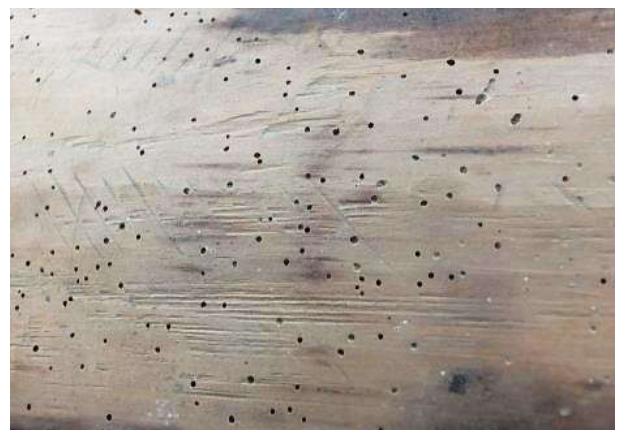
Figure 4.2: Same board as in Figure 4.1 showing reverse side hand planed. The tear lines show that this was done while the wood was still wet soon after felling.

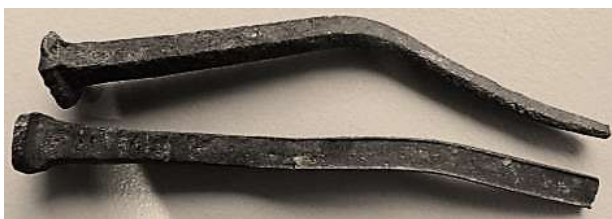
Figure 5: Ewebank nails from 1865 rear wing (top) and older c.1856-8 front bedroom (bottom).

'Ewebank' sliced and stamped or sheet cut pattern, but none were found to have that maker's characteristic post-1869 star impressed on the head. [Figure 5]. Two head patterns were noted to the largest 3 inch or 75 mm nails. One removed from the interior of the front (older part) downstairs bedroom cupboard had an irregular faceted head, consistent with the earliest Ewebank nail pattern. Historian Chris Howe has surveyed early Australian buildings and notes:

The sample nail had (machine) ejection finger marks to the upper shaft below the head while the shaft middle had the typical Ewebank bulge. The head had compression fractures indicating it may not have been red hot and lost some plasticity while being forged. Most importantly it had raised ridges to top and bottom edges of its parallel sides, caused by eccentric rollers on the 'patented' milling machine squeezing and elongating the nail rod into a new cross-sectional form.

The second nail retrieved was found in the attic part of the newer wing and had consequently degraded more because of damp. There was an unidentified 'Dot X Dot' impression to its head and it had a regular four sided tapering shaft. Another development of Henry Ewebank's was a machine with converging rollers to draw out the nail and taper it to a point. There were clear impressions of machine stamping to form the nail head observed from the folded metal under the nail head. They were on diagonally opposite 'corners' of the nail shaft suggesting two <> shaped vice heads gripping the nail as the head was hammer formed in a mould. Howe has noted that 1850s buildings in western Victoria, Australia, feature several types of nails cut from pre-profiled sheets. The nail shanks were cut from across the shaped sheet and then separately headed, consistent with a later Cordes & Co patent. Pavitt Cottage appeared also to have this pattern.

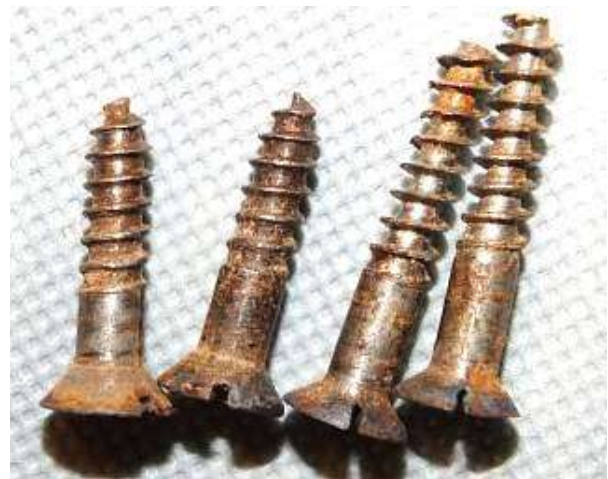
Figure 6: 1854-8 pattern screws (left) 1839-54 pattern (right).

Four original screws removed from a 'japanned' cast butt door hinge were Sloan/Nettlefold patterns, manufactured prior to 1858. [Figure 6]. Two screws had blunt tips, non-tapering shafts and deeply cut, very sharp threads when compared to the other two shorter (later but still original) screws. The two types were made quite differently, most significantly in the way the thread was formed. The blunt tipped screws had their threads cut on a die which was wound onto the blank screw rod, rotated to cut the thread. This is quite evident where the metal has been pushed sideways by the cutter's pressure to create a double lip to the initial thread. Joseph Whitworth patented his un-locking clamping nut for forming threads in 1839. The advantage was that it did not need rewinding back down the threaded screw shaft. Its use was commonplace when he displayed it at the 1851 Great Exhibition.

This 'blunt' screw pattern is typically English and can be found in New Zealand furniture until the middle to late 1850's [2]. The metal on all four screws has been squashed while hot, causing the thread to rise beyond the original extruded rod blank diameter. In 1847 New Yorker Thomas Sloan patented his machine for forming pointed screws and in 1854 Englishman John Nettlefold bought the rights to manufacture those screws from Sloan's invention. By 1858 this machine was further improved to fully taper the screw to the more familiar conical shape. The pattern of the two 'pointed' screws followed the American model. Their counter-sunk heads were angled steeper and the slots wider. Interestingly they had a rounder outer flange as though they were not entirely tool cut on a lathe but possibly stamped. No chuck or grip marks were seen on any screw upper shaft perhaps implying more automation. The important point to note is that those two screws tapered to a point quickly rather than the 'slow' progressive taper of slightly later made screws. These are in fact the first totally machine formed pointed pattern screws. It is clear that both screw types (blunt and

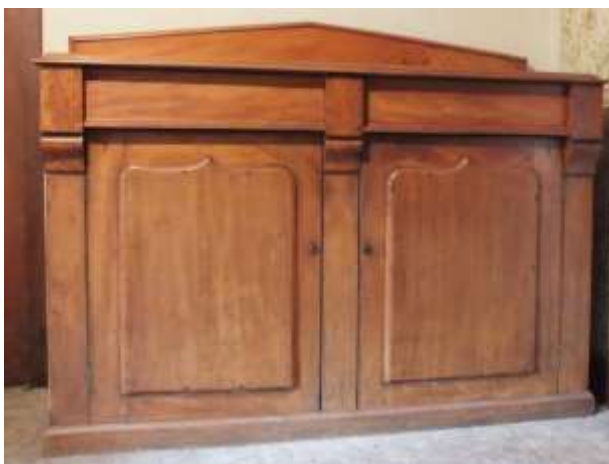
Figure 7.1: A classically inspired hand planed totara chiffonier with materials and architectural features original to Banksia, 1860.

Two cabinets could be highlighted [Figure 7.1 and 7.2]. A neo-classically inspired chiffonier of hand planed circular sawn totara planks stylistically mimicked the fire surround of the same timber. Both were almost certainly made by the same local cabinetmaker. A simple homemade plate rack dresser in figured totara was likely made from off-cuts when Banksia was first constructed as timber, tool marks and nail types all matched. The crude construction was below that of a cabinetmaker and more in line with a carpenter's skills and familiarity with wood.

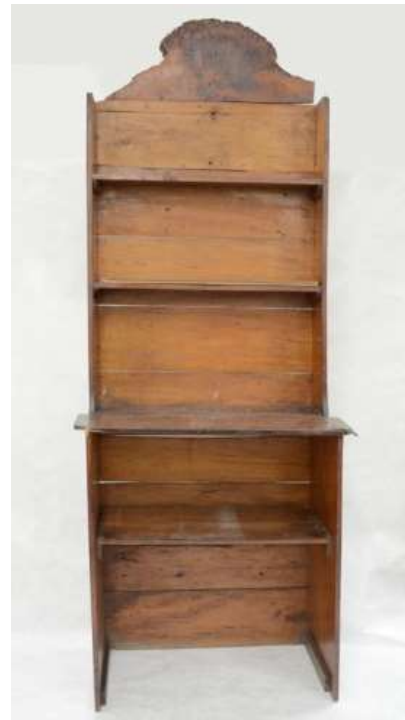
Figure 7.2: Primitive circular sawn totara dresser, original to Banksia, likely made c.1860+ from off-cut material after the construction of the house. It would not be possible to associate these two pieces on style. It was done through use of identical materials and a common history at the same property.

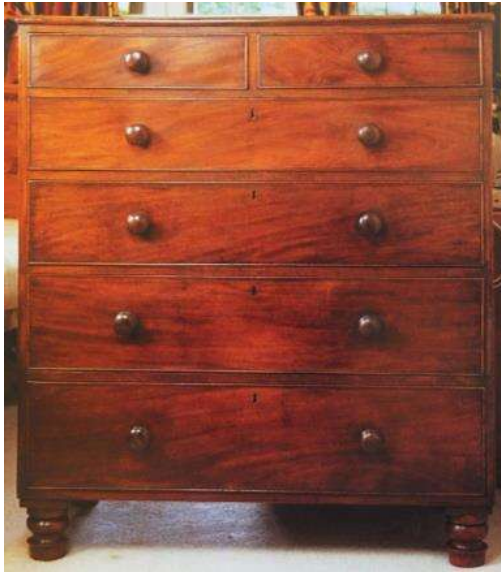
Figure 8: This c.1830 mahogany chest is possibly the oldest New Zealand made example. It was identified from its rimu and tawa drawer linings. Period design, pit-saw marks, nail types and pre-1839 screws with hand forged locks aided in dating and location of manufacture.

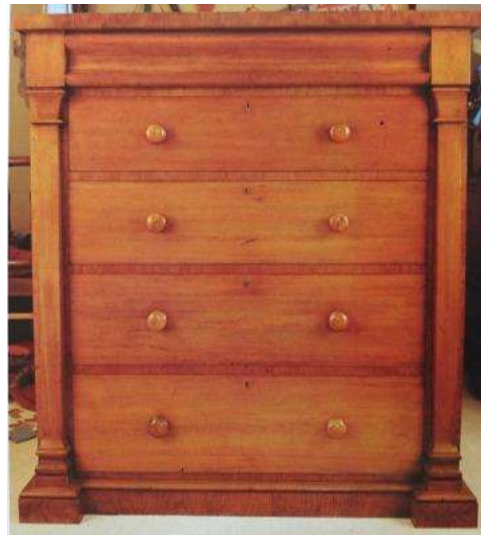
Figure 9: Restored rimu and kauri chest c.1838-9 made by Northland cabinetmaker and missionary William White. Identified by timber species, saw marks, screw & nail types, knob patterns, neo-Grecian style and provenance.
