Engineering Heritage and Nature, Finding a Balance: An Auckland Perspective on the Effects of Natural Hazards on Coastal and Marine Heritage

John Duder¹ and Dave Veart²

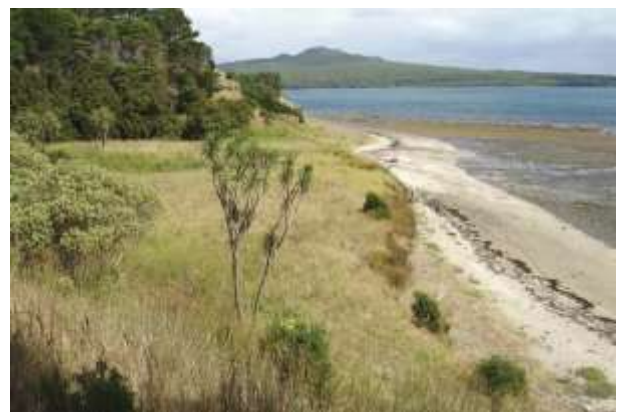
Figure 4: Sunde Site Motutapu Island (Courtesy Department of Conservation).

Since the 1960s pieces of these footprints have been eroding out of the beachfront, and since 1980 numerous attempts have been made to protect the ancient buried village, initially using timber and rubble sea walls, both of which did little to protect the site and may have exacerbated the problem.

It was initially unclear why this particular beach was eroding until some historical research indicated that scows, the flat bottomed early colonial sailing barges had collected gravel and sand for Auckland building projects. The solution to the exposure of this important site was ‘beach replenishment’. The profile in front of the old village

has remained at a higher level and while not giving 100% protection is working better than engineered solutions like breakwaters or walls.

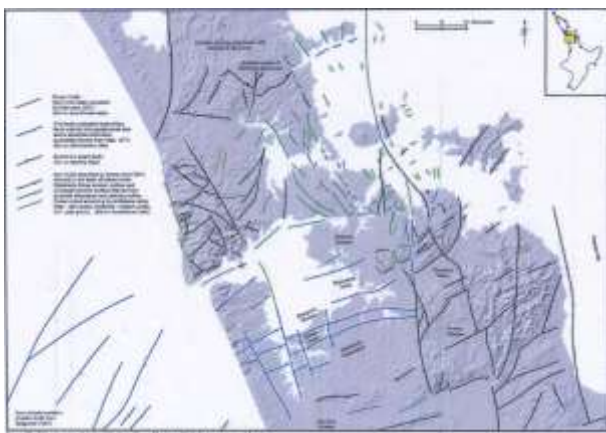
Figure 5: Faults previously recognised in the Auckland Region (Reference 1 Fig. 20b Page 40).

A recent overview of large scale faulting in the Auckland region [1] highlights the Wairoa fault as the most potentially active, but concludes that a greater risk may be from unknown faults buried under volcanic or other more recent material

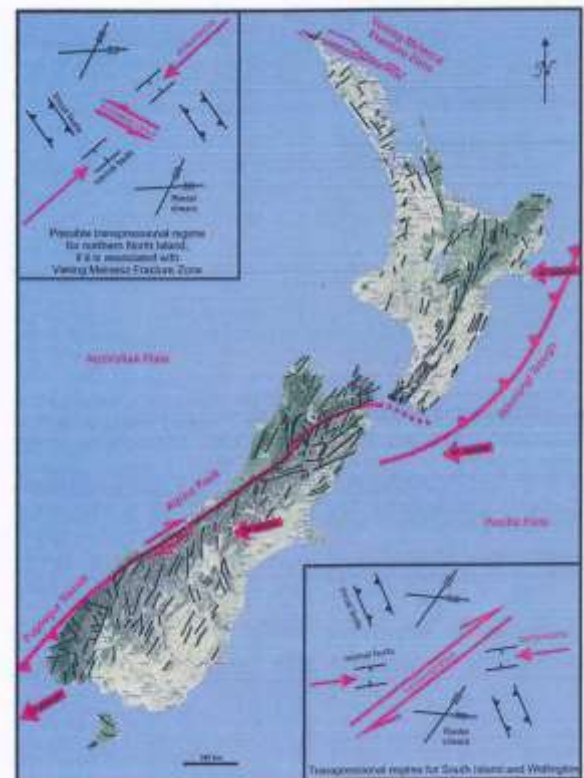
Figure 6: Hikurangi Trench and main fault lines (Reference 1 Fig32 Page 62).

Recent and ongoing research by crown research institutes, NIWA (National Institute of Water and Atmospheric Research Ltd) and GNS Science (Institute of Geological and Nuclear Sciences Limited), is defining in broad terms the risk to lower lying areas of the North Island's east coast. The East Cape and Bay of Plenty coasts are most vulnerable to near and far source tsunami, with greatest risks from undersea earthquakes on the tectonic boundary between Pacific and Australasian plates, as manifested by the Hikurangi and Kermadec subduction zones

There will be less than one hour's warning for Bay of Plenty communities from the latter and evacuation procedures are receiving priority from Civil Defence Emergency Management.

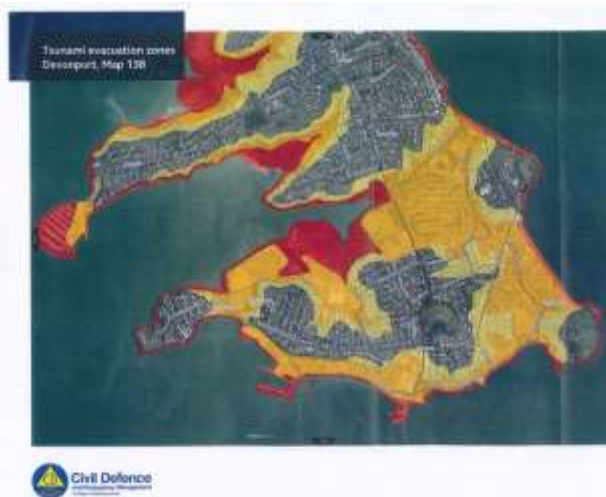
The possible effects from near field events on Auckland's east coast have been modelled and likely areas of inundation shown on publically available maps.

Figure 7: Tsunami Evacuation Zones for Devonport. Shore exclusion zone in red, evacuation zone in orange and yellow (Ministry of Civil Defence Reference 2).

Warning signs are displayed on popular beaches, and evacuation warning are being set up by telephone and siren. Tsunami responses are part of training of local emergency response groups. Auckland Council is developing data portfolios to enable local board and community response groups to inform property owners, including those

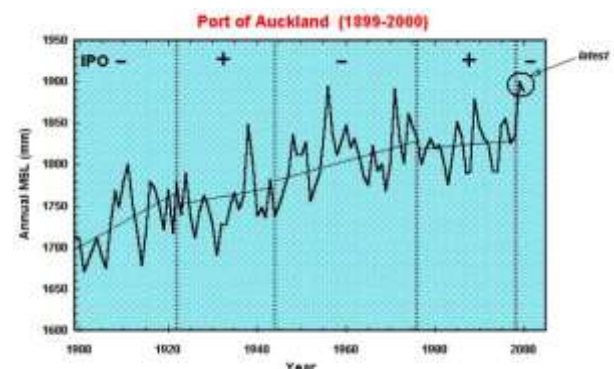
The above is the title of a NIWA report prepared in 2013 for Auckland Council [3]. The study calculated extreme sea level elevations for a range of annual exceedance probabilities. The three main harbours considered were Waitemata, Manukau and Kaipara. The Waitemata and its adjacent coast have the most heritage significance. The effects at high tide could be similar to those from tsunami. This has been experienced in recent months and is likely to become even more frequent with rising sea levels and climate change. Sea level rise at Auckland has been measured at 150 millimetres (mm) over the past 100 years, with variations mainly in sync with El Niño Southern Oscillation shifts.

Figure 8: Annual mean sea level at Port of Auckland since 1899. The overall trend has been 1.4 mm rise per year, (<http://www.niwa.co.nz/publications/wa/vol9-no4-december-2001/sea-level-on-the-move>).

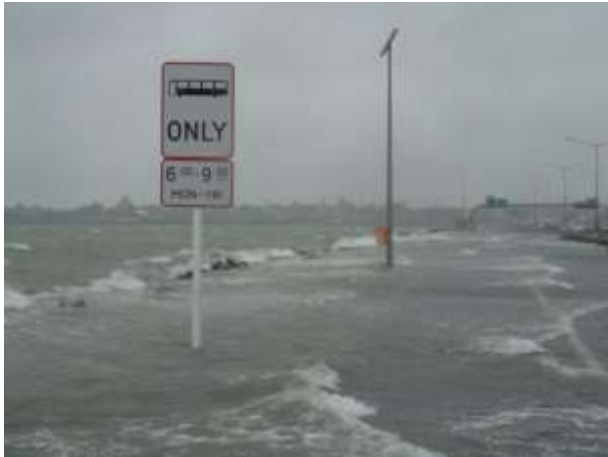
Figure 9: Flooding of the North western motorway during the 23 January 2011 storm-tide
(<http://blog.metservice.com/tag/wind/page/2/>).

The NIWA study produced inundation maps rationalising results of earlier studies, together with allowance for sea level rise scenarios of +1 and +2 metres above present day mean sea levels.
