An Exercise in Large Scale Joinery: Restoration of Three Historic Wellington & Manawatu Railway Carriages

Abstract

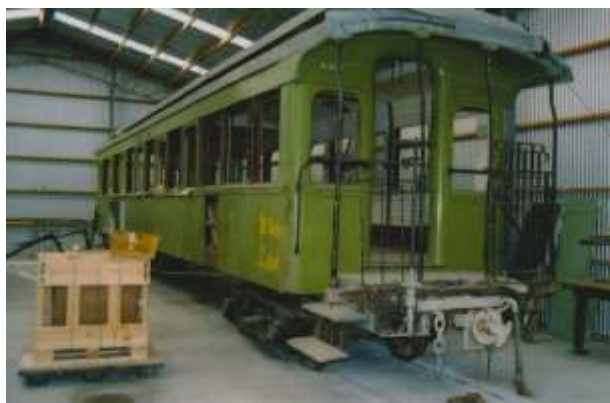
Figure 1: WMR 48 in the project workshop before restoration began, 2004.

When work began in 2004 benches, kitchen facilities, and beds installed by past owners were removed from No. 48. One exterior wall was stripped of its tongue and groove (t & g) timber cladding so the condition of the framing could be assessed. All remaining non-original fittings were removed.

Through 2004–05 the carriage was lifted off its bogies, which were taken apart, sand blasted and painted. All exterior cladding was stripped off the framing and 14 wall studs that had rot in them were replaced. Replacement t & g kauri cladding was obtained, cut to size, and primer painted ready for use later.

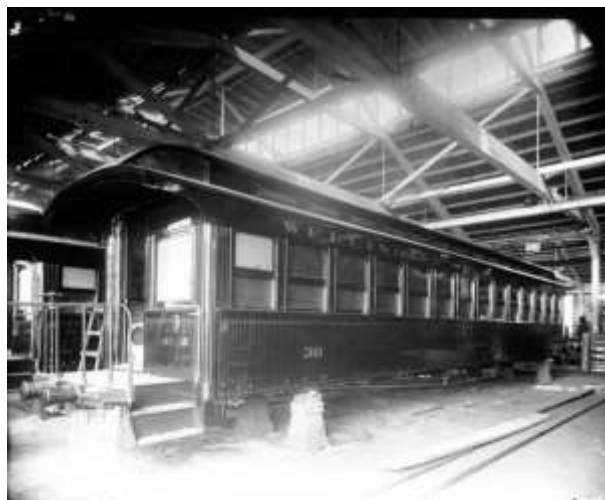
Figure 2: WMR 36 being built by Jackson & Sharp, Philadelphia, Pa., USA, 1902.

Structural and fittings design in these three followed North American practice, as a batch of similar carriages built in 1902 by Jackson & Sharp of Philadelphia, Pa., USA (Figures 2, 3). The main load bearing structure is a composite truss built in to each side wall, comprising wooden floor beams and a steel tie anchored at each end of the body. The tie rises diagonally to a cast post over the bogie centres, then runs horizontally under the window sill to above the other bogie centre. The two end arrangements are mirror images of each other.

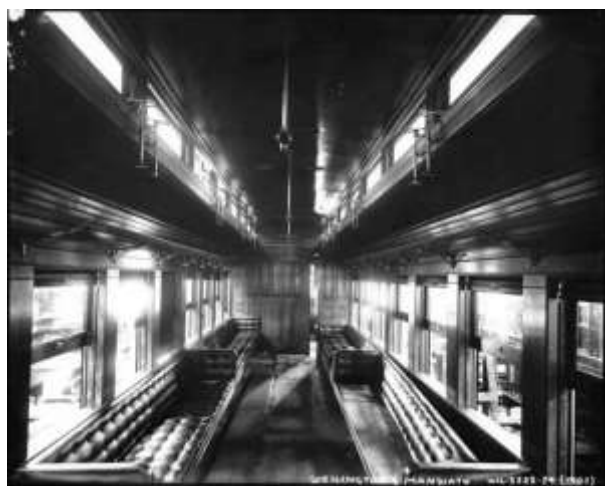
Figure 3: Interior view of 36 as built.

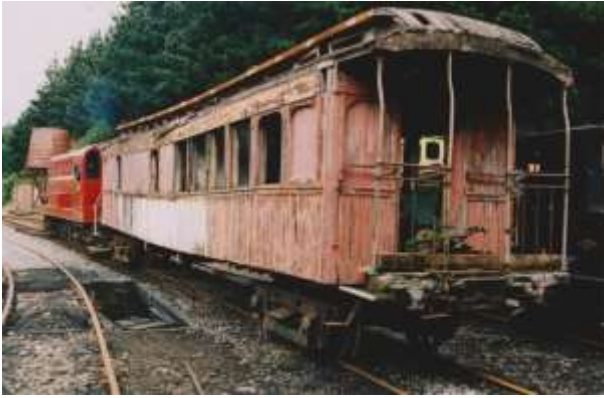
Second to be received was carriage No. 52 which had been built in 1907. This was bought in 1959 by the NZRLS Wanganui Branch. No. 52 was then sold to the traction engine society in Marton. They removed the bogies and the truss rods when these were damaged during unloading. In 1974 ownership of this carriage was transferred to the NZRLS Wellington Branch which later became the Silver Stream Railway. The carriage was stored at Seaview, Lower Hutt, until it was transported to Silverstream in 1988. The body has sagged over time after the truss rods were removed. As a result of prolonged exposure to the weather, this carriage has deteriorated worst of the three, with much rot in structural members (Figure 4).

Figure 4: WMR No. 52 being transported to the project workshop. The body sags after removal of truss rods and much rot is apparent.

No. 52 was donated to the Society in 2003. It had been left exposed to the weather for a long time and was in very poor condition, exacerbated by the removal of the truss rods earlier. The carriage was jacked off its bogies and placed on levelled trestles in the workshop to stabilise and dry out.

In 2012 a separate restoration team stripped the cladding, match-lining and floors. None of this timber was salvageable. The four kauri floor sills had advanced rot in their mid-sections and also need to be replaced.

Timber was bought in 2014 which allowed a start to be made on prefabricating replacement wall studs and diagonal braces that need renewal. Laminated finger-jointed macrocarpa beams have been obtained to replace the rotten kauri floor sills.
