SCANDRETT'S FARM, MAURANGI PENINSULA

Scandretts Farm is located on the Mahurangi Peninsula north of Auckland. This paper describes a five year project to restore the historic buildings located on the farm.

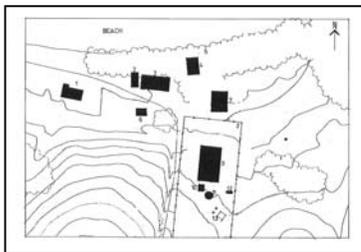
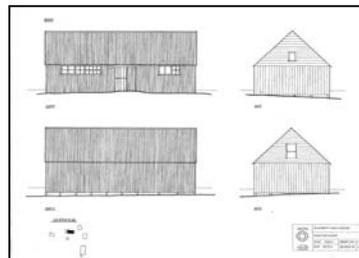
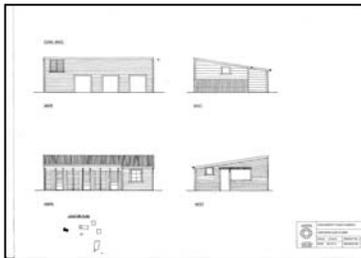
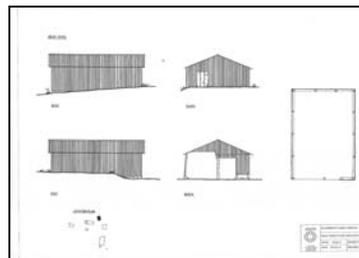
Measured drawings of Scandretts farm buildings.

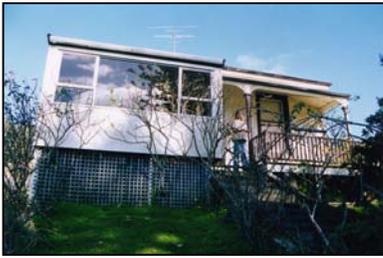
Farmhouse

- The house was built in 1885 in a simplified Georgian style.
- It was constructed of concrete with shingle brought by cutter from nearby Motuketekete Island. Analysis showed that the binder in the concrete comprised a high percentage of calcium carbonate indicating the use of lime. There was no evidence of calcium silicates of the type found in ordinary Portland cements and little or no fine aggregate component.

- The house had changed little over the years. A room was added at the front and the verandah enlarged. The building was also roughcast over the original plaster.

- By 1996, it was structurally in poor condition with large cracks evident at one corner and elsewhere as differential settlement occurred. Geotechnical investigations revealed a high water table and poorly compacted fill under the house as being the cause of the damage.

- The work comprised, firstly, the underpinning of two walls were underpinned to a depth of 2.5 metres. The northwest corner and one rear corner were reconstructed with concrete block to act as buttresses for the rest of the building. The blockwork was then plastered to match the original finish. At the same time, the front extension was removed and the verandah and front steps rebuilt.

- Future work will include replastering of the exterior and internal refurbishment.

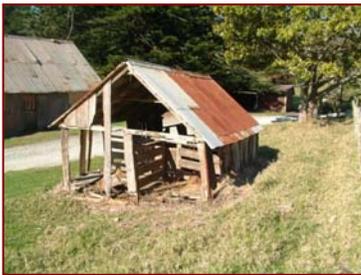
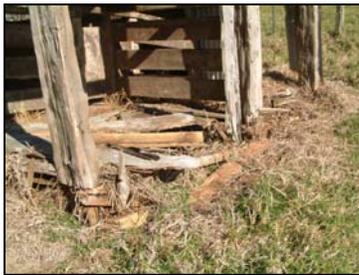
Henhouse/calf shed

- The building was originally constructed to house Thomas Scandrett's pedigree Leghorn hens and the perches can still be seen. It was later converted into a shed in which calves could be reared and the pens in the building date from this period.

- Conservation work included providing new timber piles, repairs to the framing and substantially resheathing the exterior.
- Future work is likely to include a new roof.
