# 3<sup>rd</sup> Australasian Engineering Heritage Conference 2009

## There's Naught to Fear for the Port of Oamaru

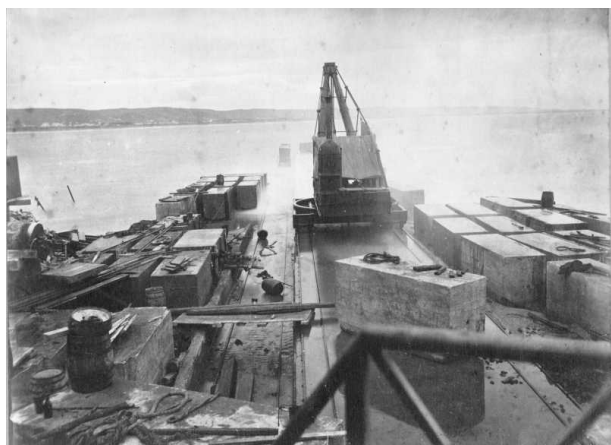
**Figure 2:** The steam crane 'Moa' working in deteriorating weather conditions. – North Otago Museum 4058

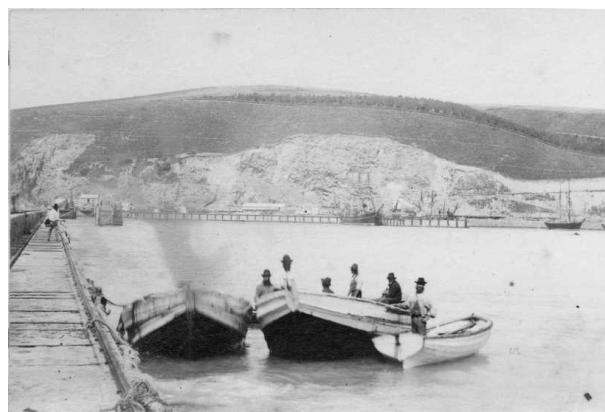
**Figure 3:** Early in 1883. A couple of surf boats are at the end of the breakwater and a wooden caisson is being towed along Macandrew Wharf to be sunk to form part of the breakwater tip. Another caisson is taking shape behind the Cross Wharf in the background. – North Otago Museum 4050

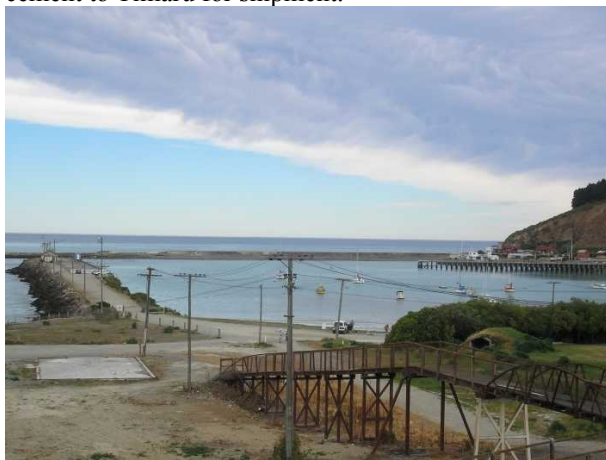
**Figure 8:** Oamaru Harbour in 2008, looking at an early 1900s railway pedestrian bridge and Holmes Wharf. – Gavin McLean

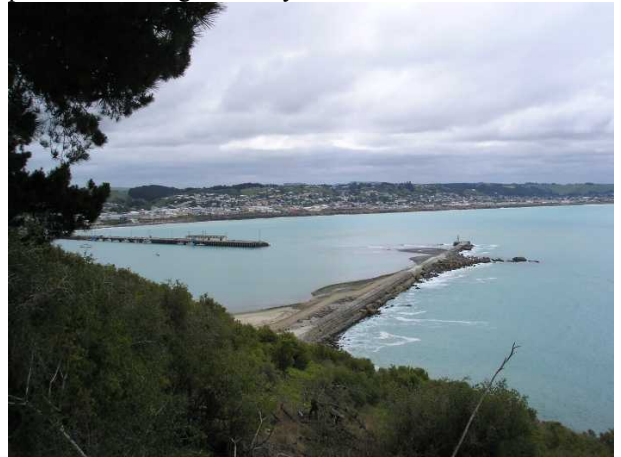
**Figure 9:** Holmes Wharf (left) and the breakwater, viewed from Cape Wanbrow in 2008. The large rocks on the seaward side are the remains of the Ramsay Extension. – Gavin McLean
