The Need for Adaptability in River Control Design to cope with Climate Change and other Flood Hazard Uncertainties

1. ABSTRACT

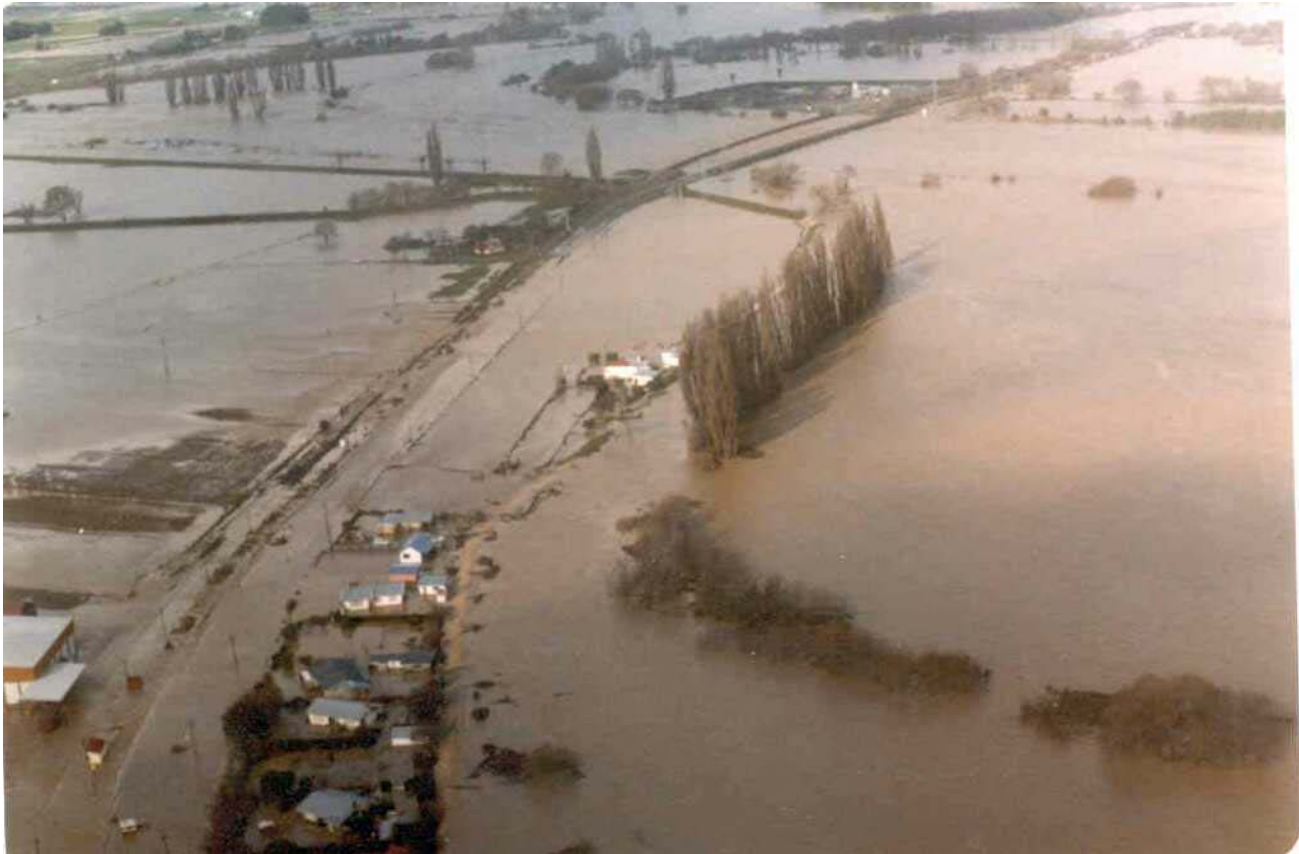
FIGURE 2: Wairau at Tuamarina, July 1983 flood

The review paid particular attention to the July 1983 Wairau flood, which is the largest known flood since at least 1868. It caused stopbank overtopping, failure and flood breakout at four major locations and a dozen minor locations. The river and flood breakout at Tuamarina bridge is shown in Figure 2.

Assessment of 1983 flood size had proved difficult. This was because of uncertainty of the rating curve at high stages, and the difficulty of measuring flood breakouts. The immediate Catchment Board flood estimate in 1983 was a size of 7,765 m^3/sec . This was reviewed down the following year to 7,000 m^3/sec .

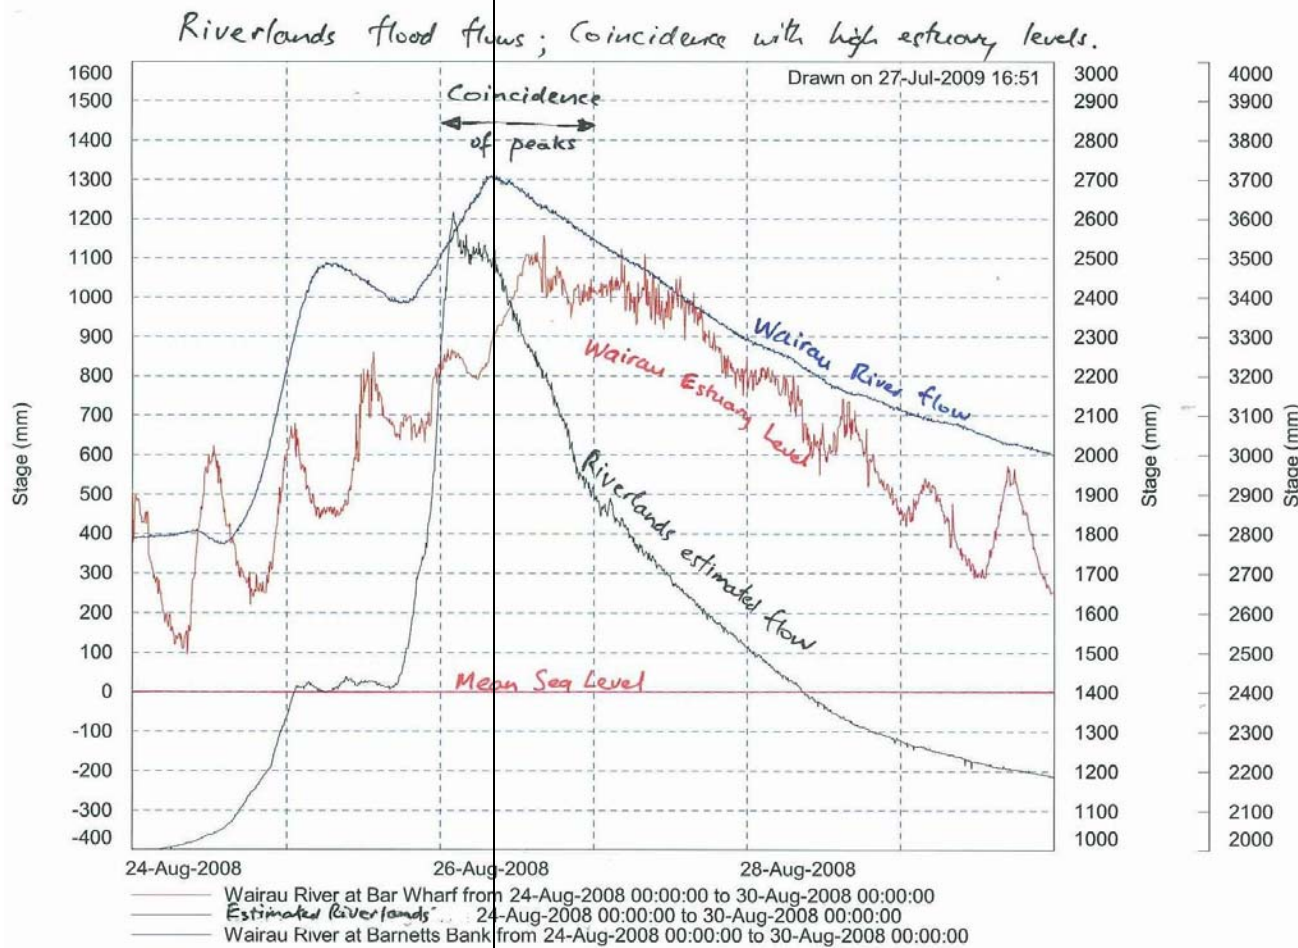
FIGURE 4: Riverlands Co-op flood flows, coincidence with high Wairau Estuary levels

The main reason for the poor performance of the floodway was due to high estuary levels persisting for over 2 days. This was caused by coincidence of the Riverlands flood with a Wairau flood, an inefficient river mouth to the sea, and high tide.

This is shown in Figure 4.

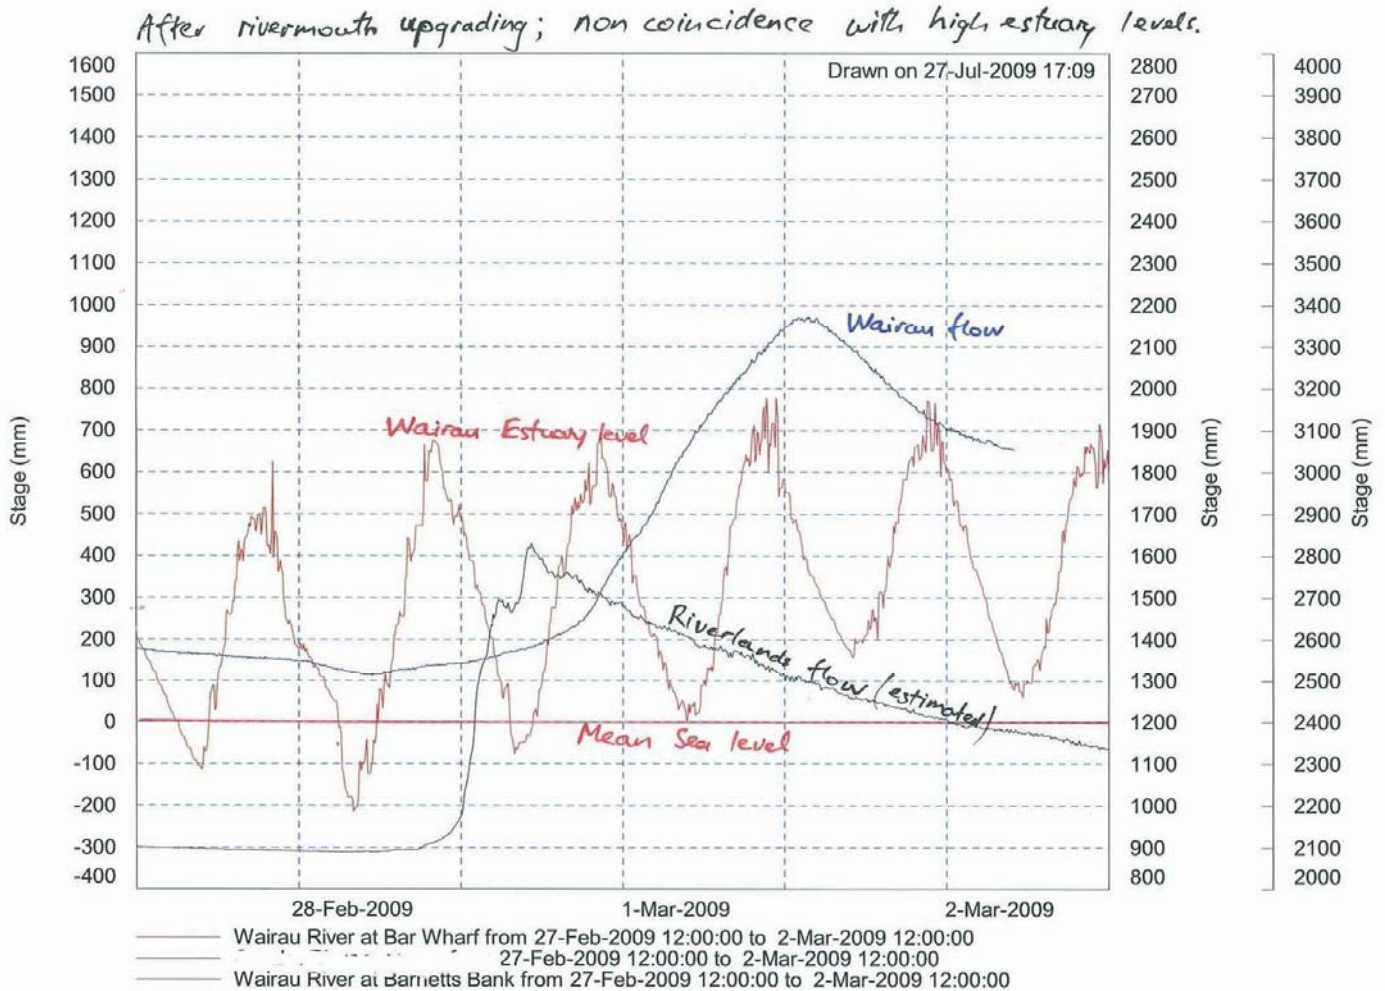
FIGURE 6: Riverlands Co-op Floodway flows; non-coincidence with Wairau Estuary levels

The benefit of this is demonstrated by a small flood in Feb 2009. Estuary levels were 0.5 m lower during this Riverlands flood and limited to the few hours of high tide, as shown in Figure 6.

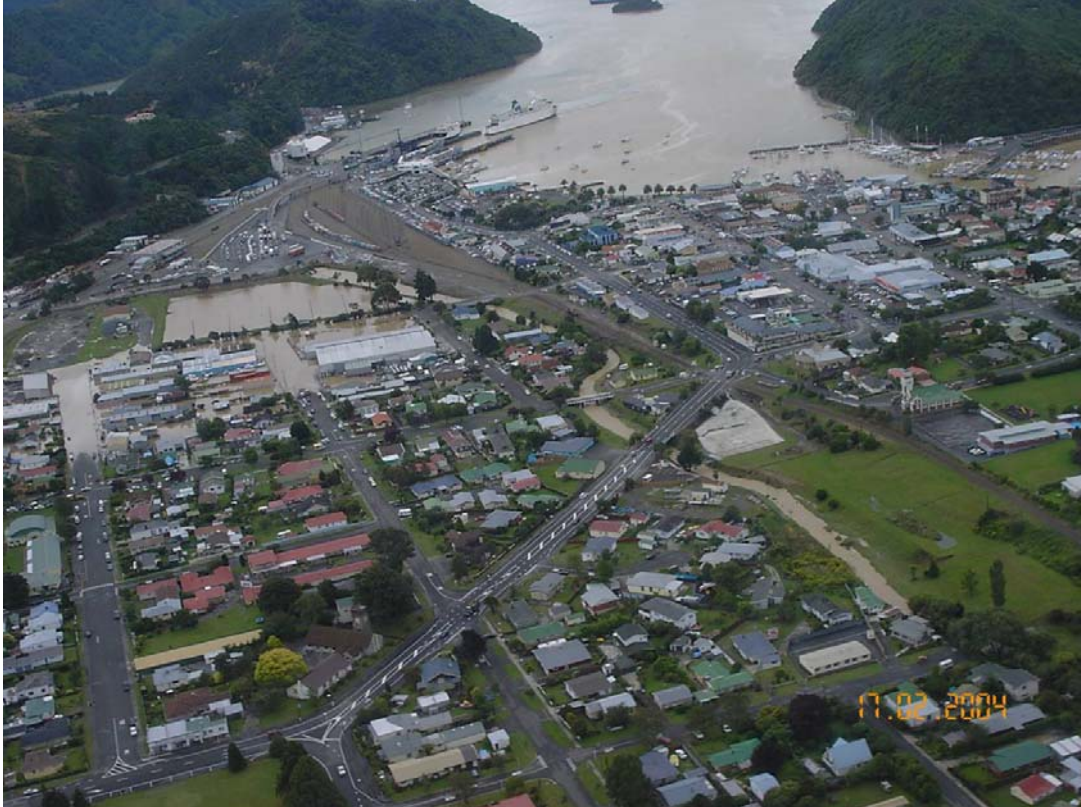
FIGURE 7: Picton February 2004, Industrial area flooded due to inadequate size of culvert under wharves

The culvert was not large enough for the floods of 1998, 2004 and 2008. The water backed up behind the culvert and flooded the industrial area of Picton. There is no secondary overflow

path, and water can build up behind the culvert flooding an eight hectare area of town by up to 1.5 m.
