# New Zealand's Easy Merge Ramp Signal (Ramp Metering) Trial

*This paper reports on the trial of the Easy Merge Ramp Signal (ramp metering) that commenced on 1 March 2004 at the Mahunga Drive northbound on-ramp on SH20. This is one of the first ramp metering trials in New Zealand.*

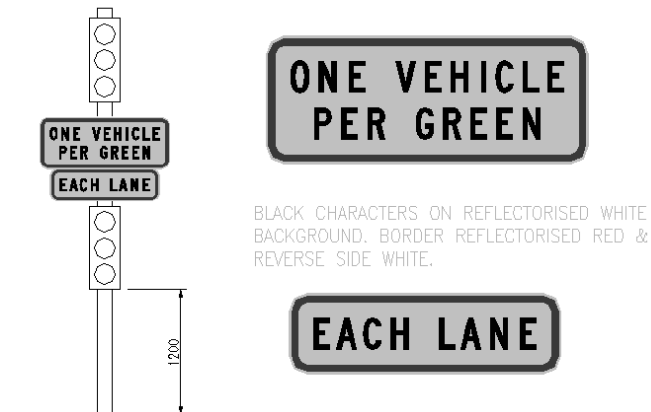
Figure 3: Ramp Meter Display A

The ramp metering system involved a series of three separate displays. Display A (see Figure 13) consists of two single-column, 3-aspect traffic signals separated by a regulatory traffic sign that displays the words “One Vehicle Per Green Each Lane”. The purpose of this regulatory sign is to inform drivers that only one vehicle is permitted to discharge per lane when the green signal is displayed. This sign also enables enforcement of the ramp signals.

The signs at Display A (mounted on the signal poles) displaying the words “One Vehicle Per Green Each Lane”, in conjunction with the combined green and yellow time of 2 seconds, have proven effective in metering the ramp flow as demonstrated with the high compliance rate discussed above.

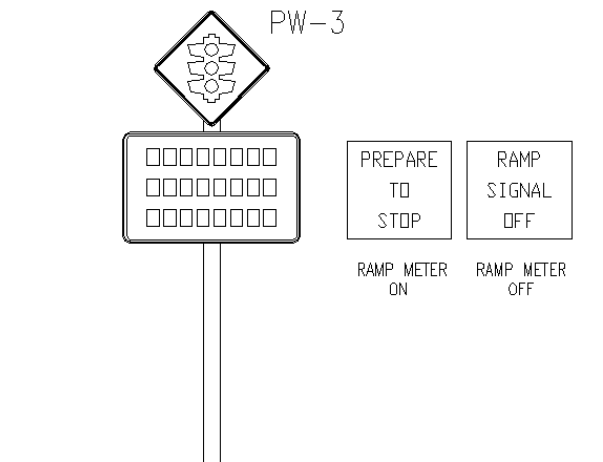
Figure 5: Ramp Meter Display C

Display C (see Figure 5) is the standard PW-3 sign and a VMS. This VMS displays either the words ‘Prepare to Stop’ or ‘Ramp Signal Off’. Display C is located at the adjoining arterial road. These signs are used to warn motorists of the impending signals and the state in which they are in.

The signs at Display C, located near the top of the ramp, include a PW-3 sign and a VMS sign with alternating displays to warn drivers of the ramp signals and the state at which they are in. When the ramp signal is operating (including start-up and shut-down periods) the VMS displays the message “Prepare to Stop”. When the ramp signal is not operating, the VMS displays the message “Ramp Signal Off”. The form and location of these signs have proven to be effective with no occurrences of motorists stopping at the signals when the ramp signal is not in operation and no recorded rear end accidents on the ramp since the commissioning of the ramp metering system.

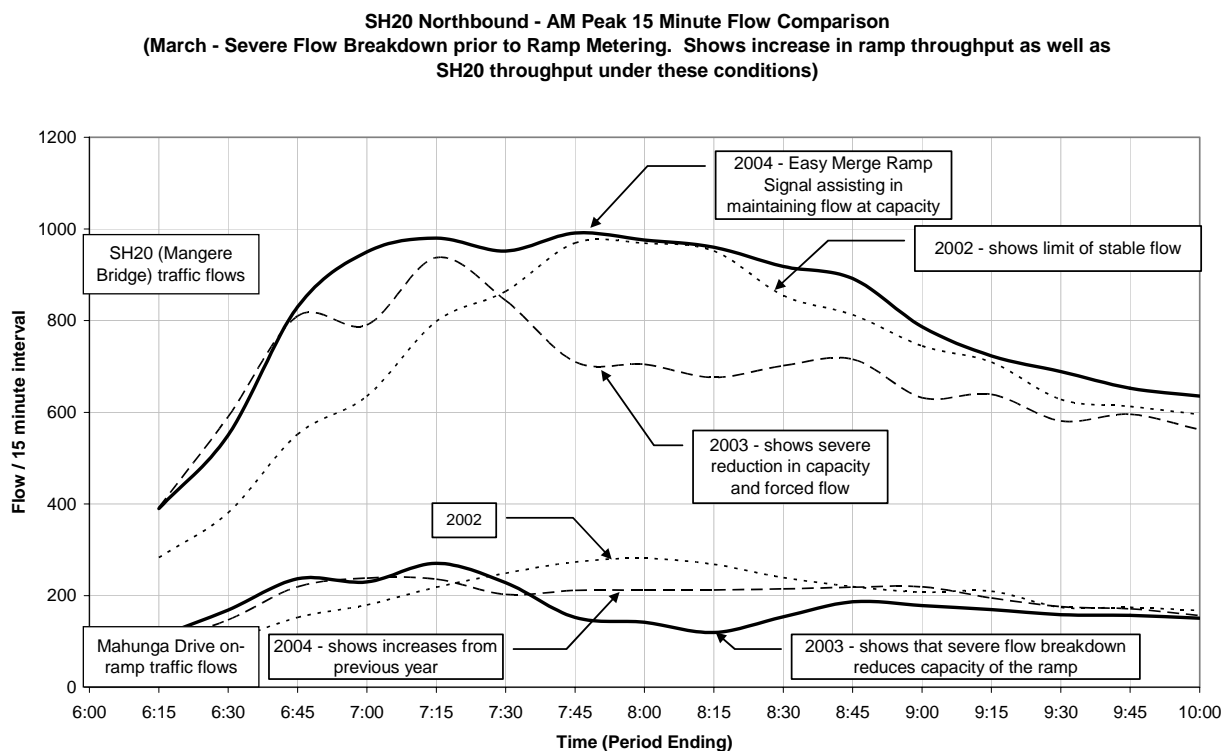
Figure 7: Morning peak period throughput

The flow profiles (see **Figure 7** and **Figure 8**) through the two years prior to commissioning show a declining performance of SH20 upstream of the Mahunga Drive on-ramp between 2002 and 2003, represented by the marked decreases in throughput volume.

The graphs indicate continuing traffic growth in traffic in the pre-peak period, therefore the decrease in volume shown in the graphs is due to flow breakdown and forced flow rather than a decrease in demand. The operation of the ramp metering system has clearly minimised this condition and contributed to the following:

- Increases in throughput in two lanes prior to the merge area from as low as 3,400vph in 2003 to as high as 4,000vph in the peak hour (3% - 15% increase on pre-metering flow conditions)
- Increase in throughput on SH20 from as low as 2,400vph as high as 3,300vph in the peak hour (9% - 26% increase on pre-metering flow conditions)
- Increase in ratio of SH20 traffic to total traffic over Mangere Bridge from 70-75% on SH20 pre-metering to upwards of 80% on SH20 post-metering.

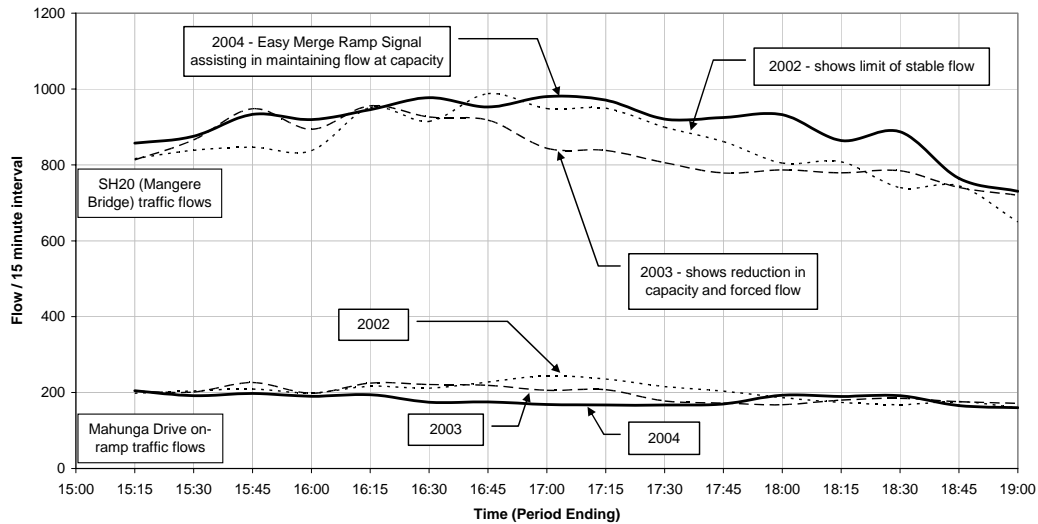
**SH20 Northbound - PM Peak 15 Minute Flow Comparison**  
 (October - Moderate Flow Breakdown prior to Ramp Metering. Shows improvements in SH20 throughput and low change to ramp throughput)

Figure 8: Evening peak period throughput

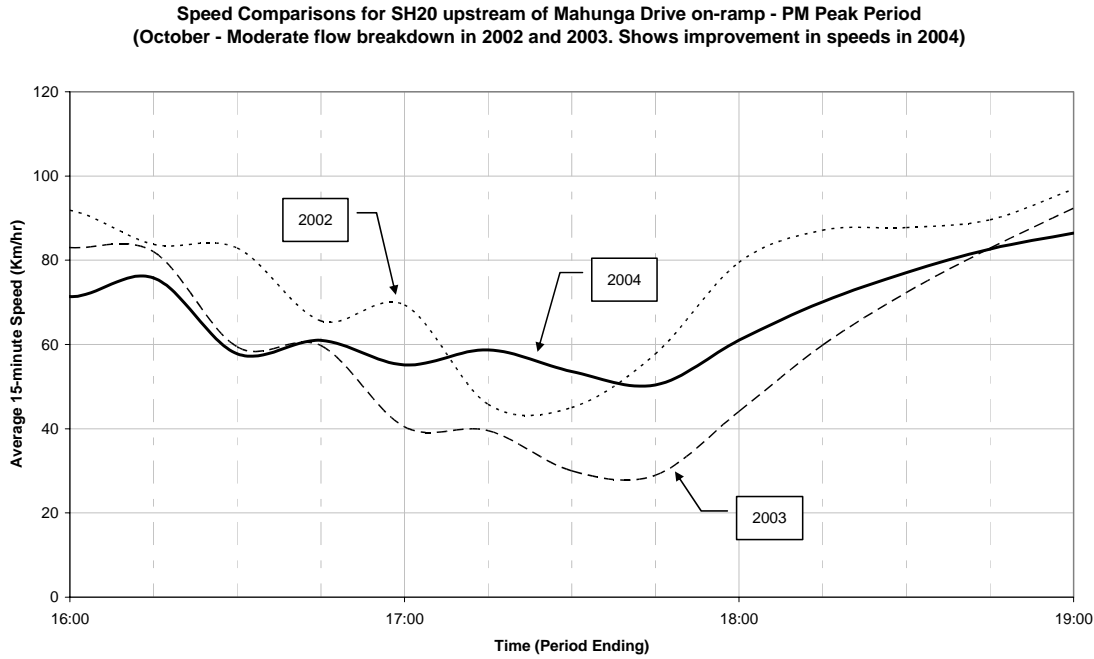
Figure 10: Evening peak period speed profiles

The speed profiles show a significant decline in speed prior to ramp metering in both the morning and evening peak periods. The morning peak period shows widely varying results, which upon inspection of the data for each individual day indicates high variability in the evening peak traffic conditions.

The ramp metering system has reduced the variability of speed along SH20 especially in the evening peak period. An increase in fifteen minute average speeds from 25 - 35kph to 40 - 50kph were also achieved. This represents an increase in between 5kph and 15kph from the previous year. This reduction in travel speed variability indicates that trip reliability has improved and potentially contributes to reduction of “high-speed rear end” type accidents through the merge area.

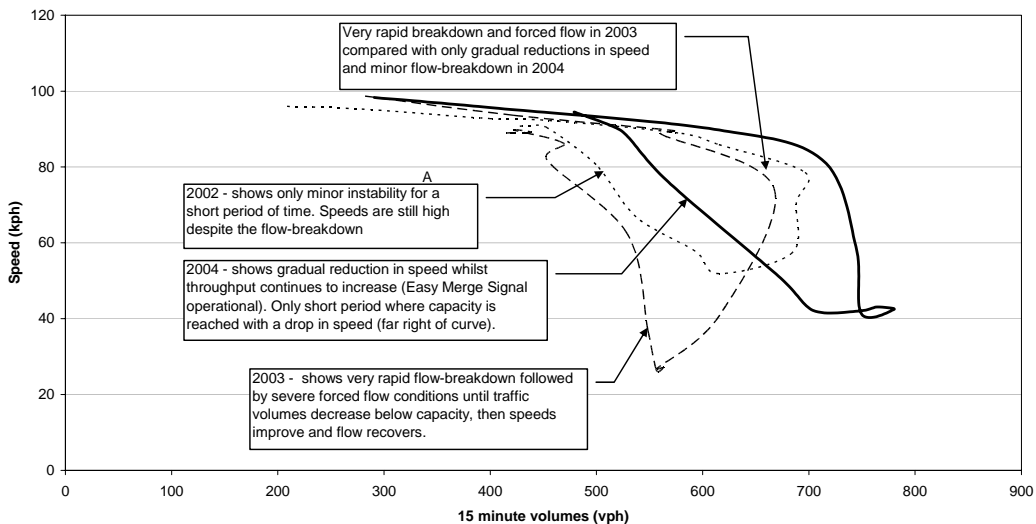
**Speed Flow Relationships for SH20 upstream of Mahunga Drive on-ramp - AM Peak Period**  
(March - severe flow breakdown prior to Ramp Metering. Shows improvement in severity of flow breakdown)

Figure 11: Morning peak period traffic flow conditions

The speed flow profiles (see **Figure 11** and **Figure 12**) indicate that prior to ramp metering, the onset of flow breakdown was very rapid, as illustrated by the near vertical drop in the curves. The profiles show that ramp metering has both increased throughput and reduced the severity and duration of flow breakdown.

In both the morning and evening peak period, there were only relatively short periods where forced flow conditions occurred after the activation of the ramp metering system. Analysis of the CCTV footage confirmed the improvement in the operation of the merge area with much less instability and improved speeds through the merge area.

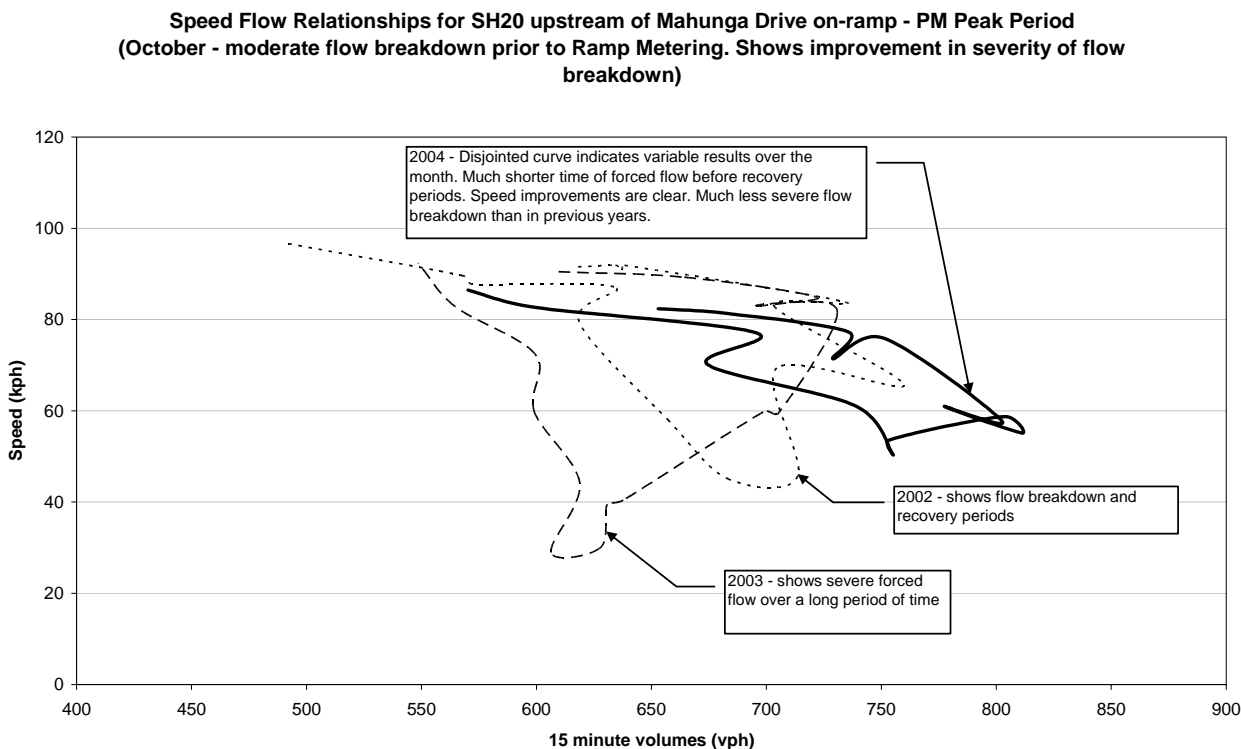
Figure 12: Evening peak period traffic flow conditions

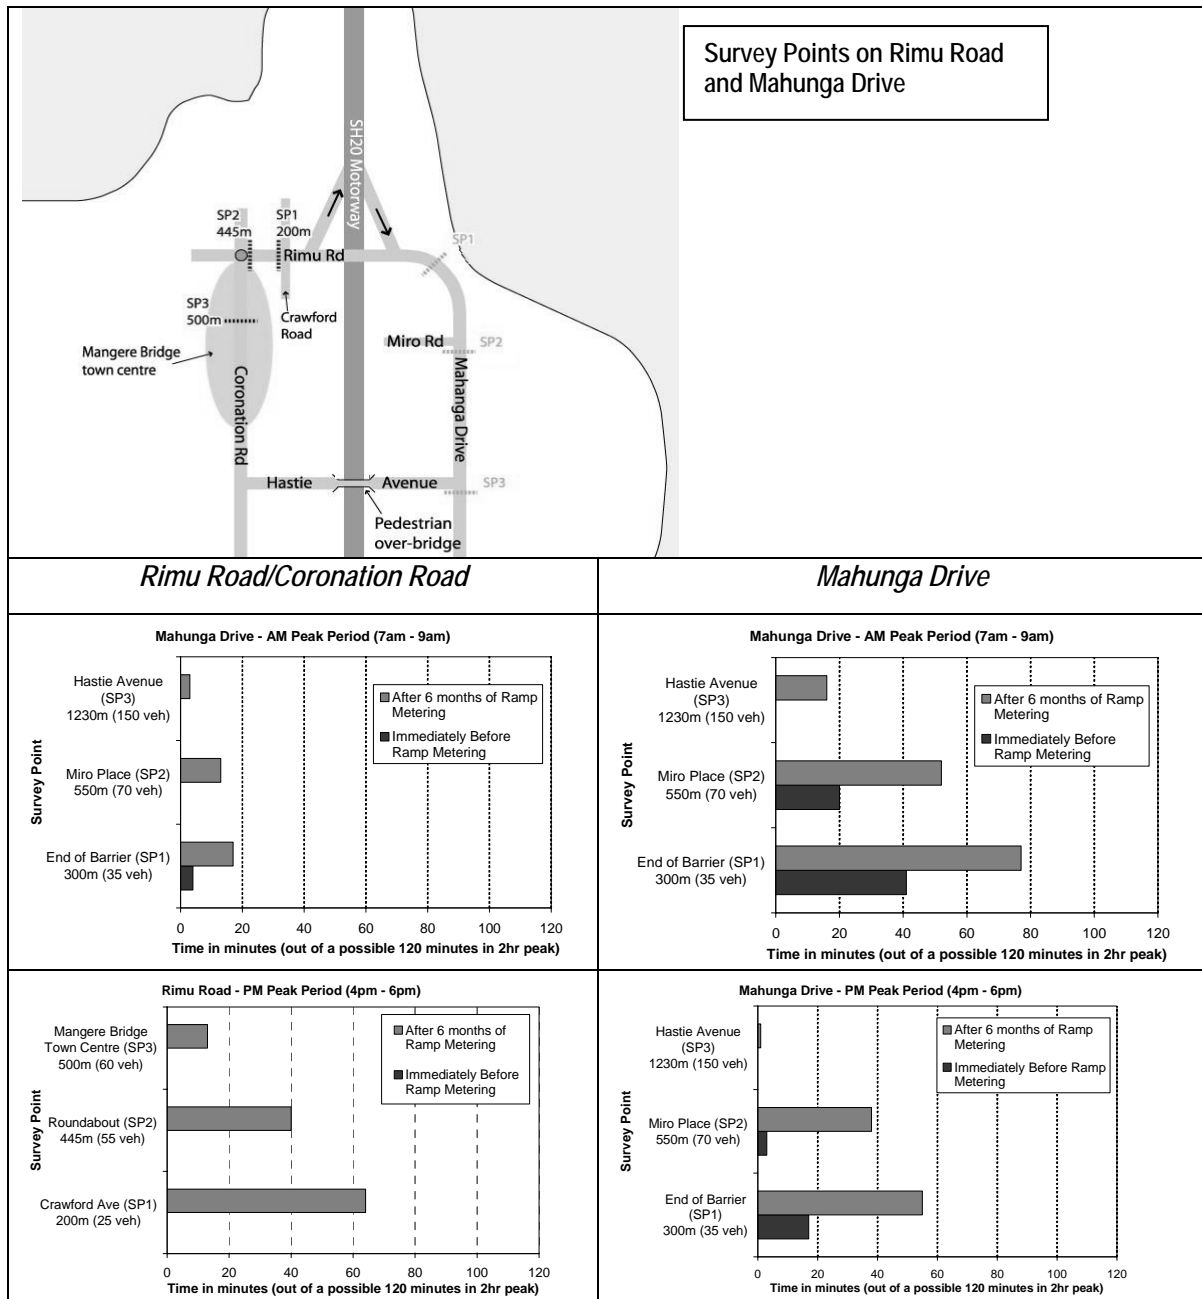
Figure 13: Queuing levels over the two hour peak periods

**Figure 13** shows the average time on representative workdays (Tuesday, Wednesday and Thursday) that queues extend beyond specific points (not waiting time). The measurements are given in minutes over the two hour period.

In general the amount of time where queuing exists has increased as a result of ramp metering. However, an inspection of the daily data six months of ramp metering shows that the longest queue observed are no worse than they were prior to ramp metering, even though queues exist for a longer period. Inspection of the daily data both prior to ramp metering and after six months of operation shows that the queue lengths are very much dependent on the operation of the motorway. Under normal traffic conditions, traffic queues vary from 400-500 metres in length. As experienced previously, longer queues periodically occur during abnormally heavy conditions.

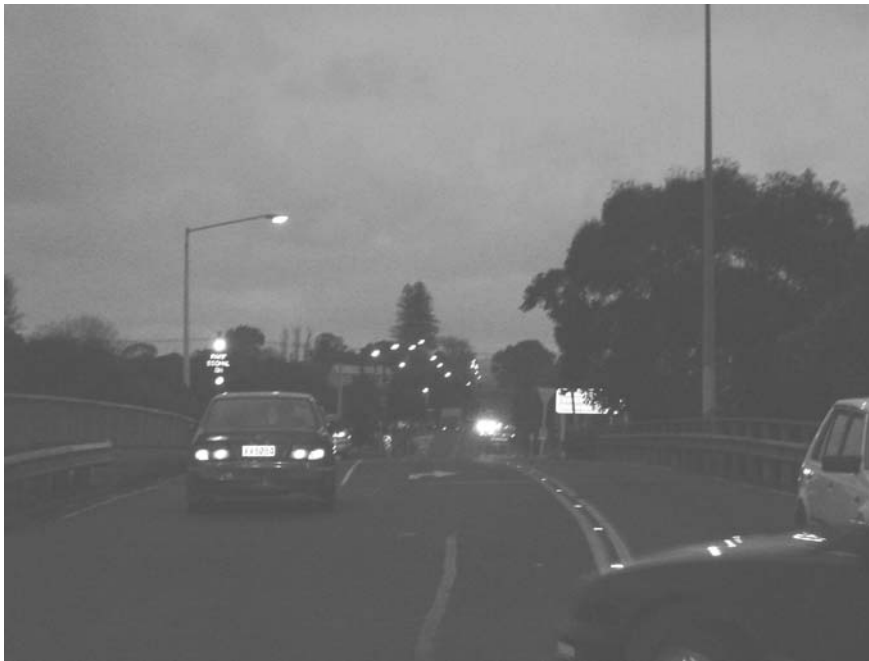
Figure 15: Advance Warning Sign on Mahunga Drive

The message on the sign is effective in advising motorists that the signals are in operation; however the legibility and location of the signs have arisen as issues that should also be addressed for future installations. The sign located on the left hand side of Mahunga Drive for traffic turning right on to the ramp was observed to confuse the occasional motorist, probably not familiar with the system. The yellow LED display was difficult to read from a distance because of the intensity of the flashing yellow signal aspects. This is more evident at night (refer to **Figure 15**). A larger space between the LED sign and the flashing yellow aspects should be considered for future installations.

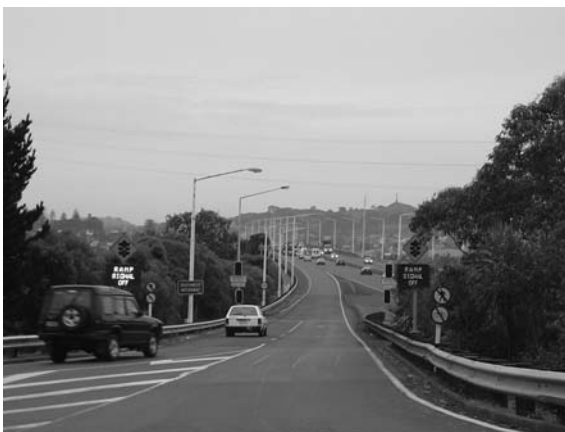
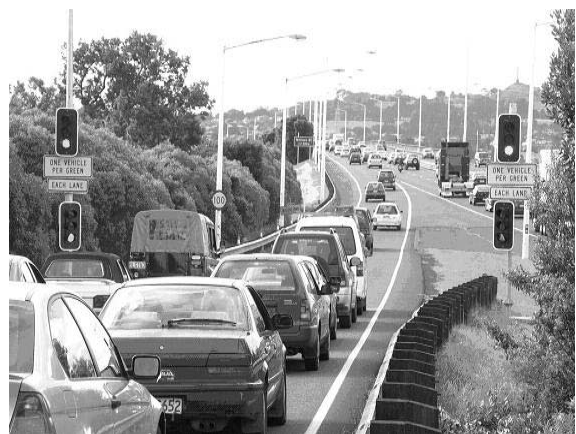
Figure 16: Photos of the Easy Merge Ramp Signal in operation

The use of high mounted and low mounted signals has been successful in providing displays visible by both approaching traffic and traffic at the limit lines (warning/stopping function and starting functions respectively). The signals and their location have contributed to the high level of compliance observed.
