Seismic Strengthening and Restoration of Cargill's Monument

Bevan White¹, Geoff Anderson² and Jerry Kearney³

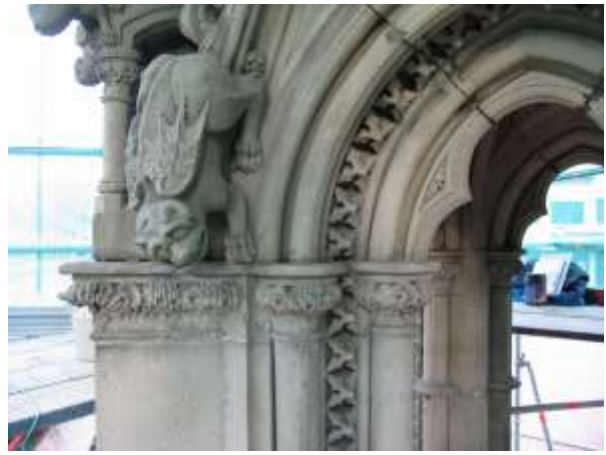
A full topographic survey was carried out to accurately determine structural dimensions. The monument had two levels of stone arches and cross sections progressively narrowing to the intricate spire at the top. A variety of finials and grotesques [Figures 4 and 5] adorn the structure and these needed to be included in the strengthening design.

Figure 4: Grotesques and lower arch.

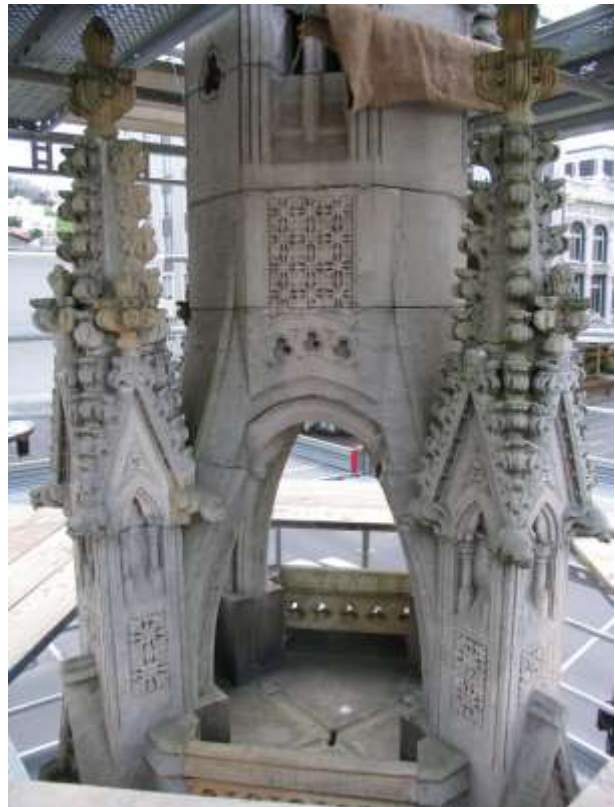
Figure 5: Decorated finials and upper arch.
