# *3<sup>rd</sup> Australasian Engineering Heritage Conference 2009*

## **Port Craig Viaducts Engineering Assessment and Conservation Plan**

Trevor Butler, BE(Hons); MBA(Exec), CPEng(Civil,Struct), Director Frame Group Ltd

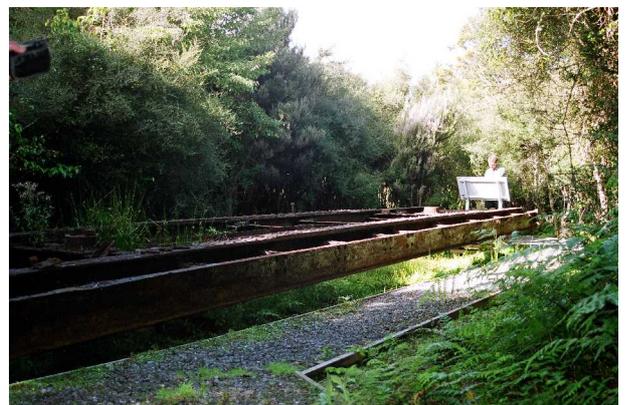
**Figure 1.** *Lidgerwood chassis on the interpretative walk at Port Craig. (Crown Copyright: Department of Conservation, Te Papa Atawhai, 2005, Photographer: Rachael Egerton.)*
