# The Strengthening of Heritage Buildings – Construction Challenges

## Abstract

## 1. Introduction

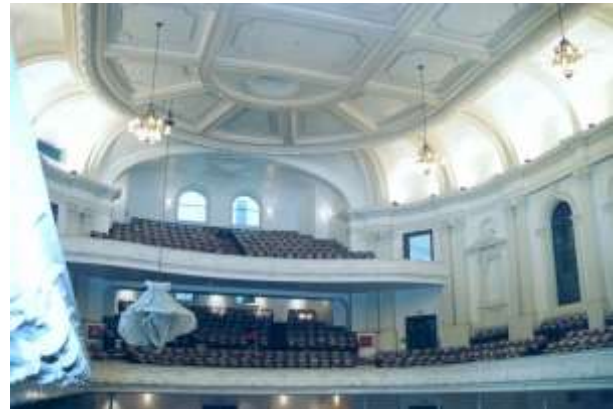
Figure 2: The Great Hall during refurbishment.

By contrast, the Great Hall was inconveniently large. In order to access the ceiling for painting and restoration, scaffolding of the entire auditorium was necessary.

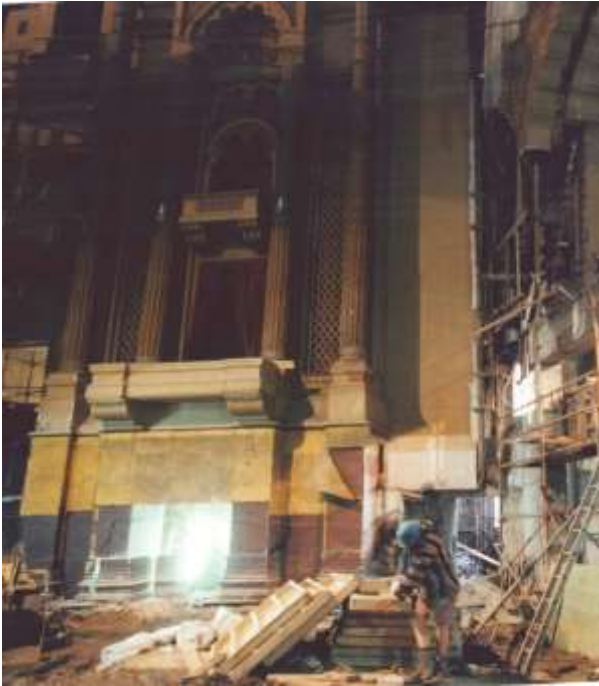
Figure 8: Opera Box Stage Right (before raising).

The raising of the Opera Boxes was equally innovative. Once again the objective was to keep the structures in one piece to eliminate time-consuming de-construction and re-construction.

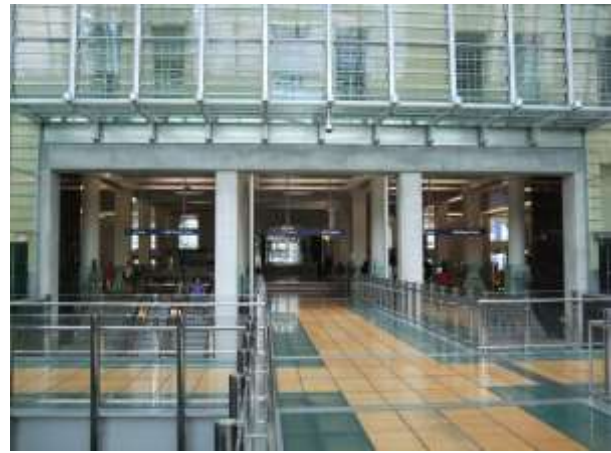
Figure 12: The new columns & beam in the rear wall.

One of the major undertakings was to create an opening 20 m wide by 10 m high in the rear brick wall of the building. This was needed to provide a spacious and naturally lit opening for the escalators and stairs from the platforms below.

Temporary support was needed for the opening in the rear wall while the new columns and beam were cast. The trick was to design a support system that would not get in the way of the new work!

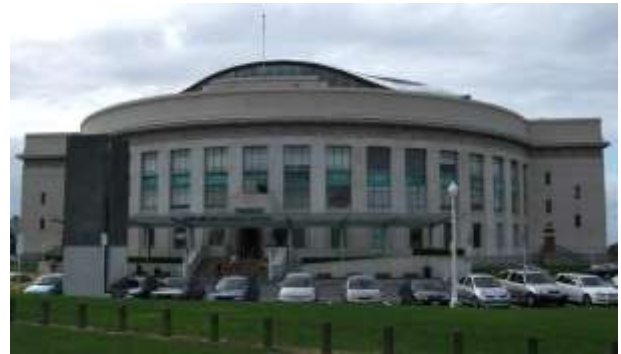
Figure 17: The wave-like roof of the new Grand Atrium is just visible in this photo of the rear of the Museum.

During the restoration and strengthening of the Museum in 2004–2007 new utility and exhibition spaces were constructed. This included underground car parking and a Grand Atrium

constructed within the semi-circular courtyard at the rear. This was a challenging task described as constructing a 7-storey building within the confines of a heritage building.

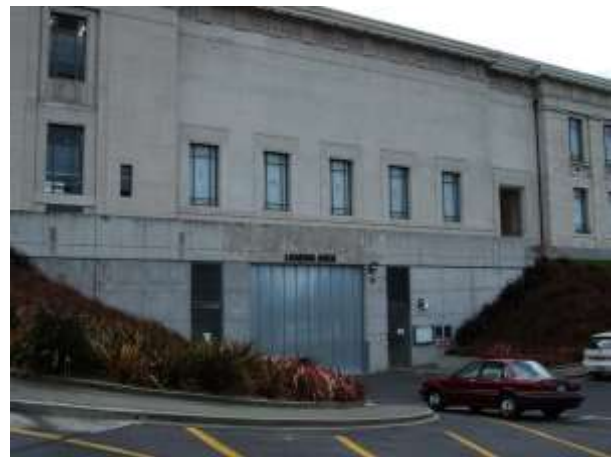
Figure 18: The new truck dock entrance.

A major challenge for the Contractor was the construction of a truck dock entrance to a new underground loading bay.

A section of the perimeter foundation beam had to be removed and new beams cast. Self compacting concrete was used under the existing structure so that full load bearing contact could be achieved. When the concrete for the new beams had hardened, it was post tensioned with high strength stressing wires.

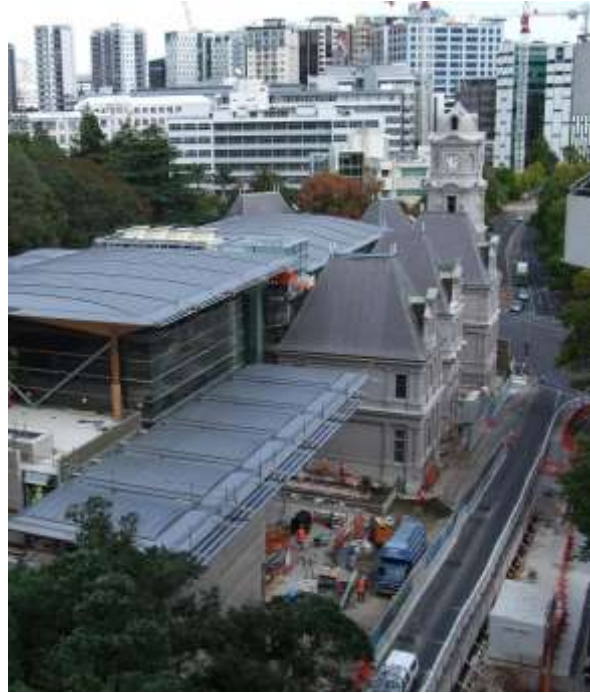
Figure 21: The new glazed atrium extension during construction.

New electrical, plumbing, air conditioning, fire protection and security systems were installed as part of the upgrade. Some of the more recent additions to the Art Gallery were demolished to make way for a new 5-level extension featuring a glazed atrium.
