3rd Australasian Engineering Heritage Conference 2009

Queensland's timber and iron lighthouses: 19th century colonial innovation.

Peter Marquis-Kyle, conservation architect, Brisbane

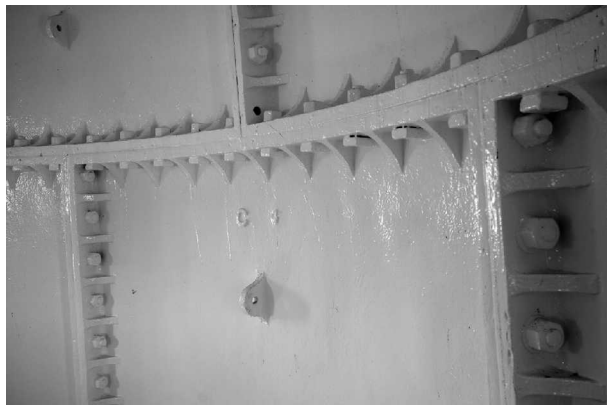
Figure 2. The cast iron plates of the Bustard Head lighthouse tower

The two cast iron lighthouses were erected by private building contractors under the supervision of officers of the Department of Public Works and with the advice of the Portmaster. The contractors also built timber houses for the light keepers. Erecting the iron lighthouses was quick, but getting the lighthouse components and other materials to the sites and preparing concrete bases beforehand took many months. The departmental staff and the contractors learned some useful lessons about the best ways to organise the works – lessons they would later apply to other lighthouse projects.

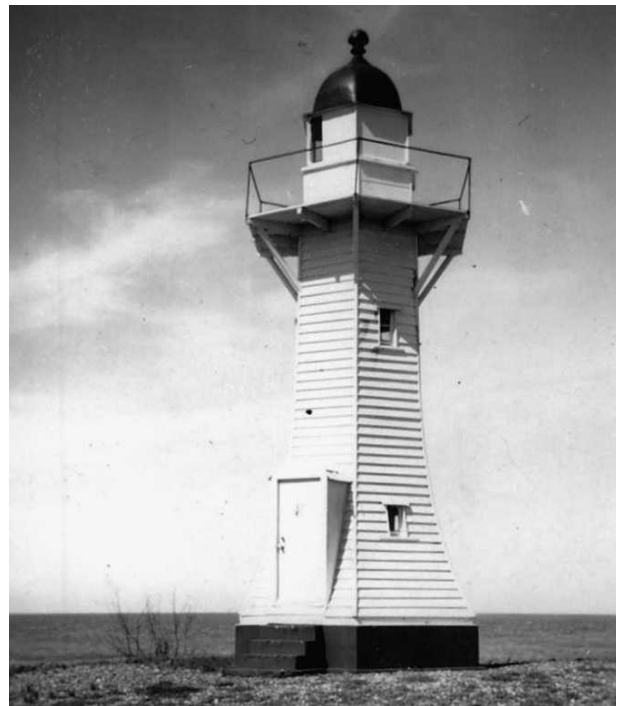
Figure 3. Burnett Heads lighthouse (photo: Bundaberg Regional Council collection)

These timber towers – with their hardwood frames, truncated pyramidal forms, and horizontal weatherboard sheeting – were similar to New Zealand lighthouses designed by John Blackett through the 1870s and 1880s.⁷ Blackett acknowledged North American precedents for such forms, and there may have been American influences on the Queensland designs too. While Blackett was refining the design of timber lighthouse towers to improve stiffness, wind resistance and durability, the Queensland designers were finding different ways to deal with these problems.

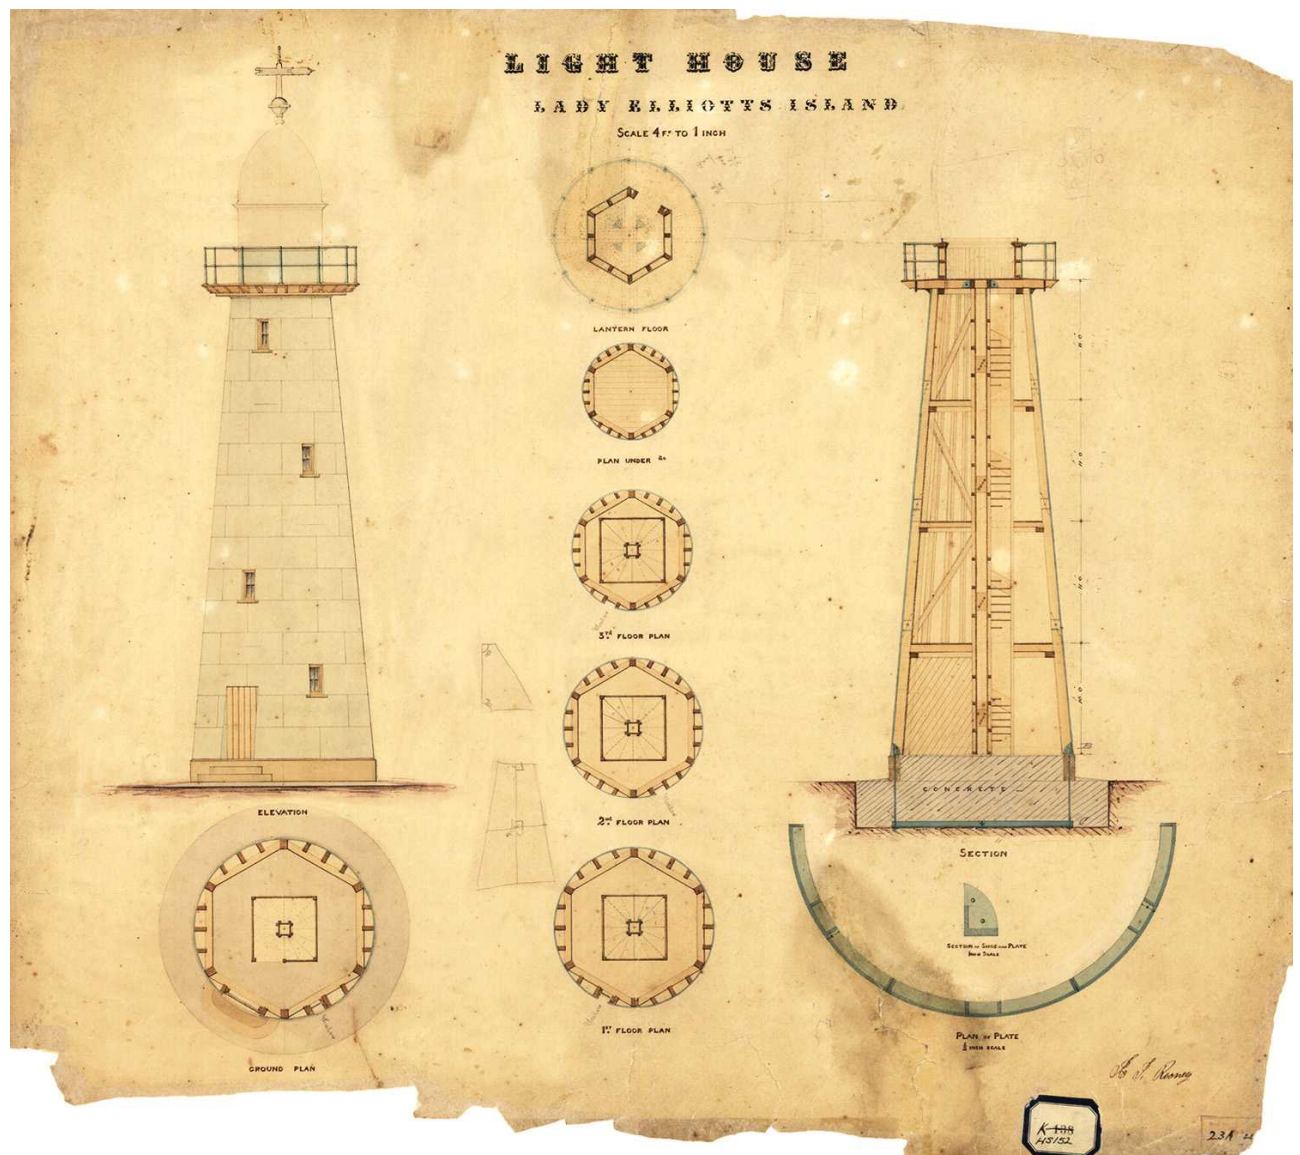
Figure 4. One of the contract drawings for the construction of the Lady Elliot Island lighthouse

The lighthouse tower was round in plan and tapered in profile, forming a truncated cone. The battered outer walls were framed with sawn hardwood posts and rails bolted together, with joints reinforced with wrought iron straps and brackets. The walls had light timber braces which would have served to stabilise the timber structure before the iron shell was fitted. There were three intermediate floors with hardwood joists and pine floor boards. In the centre of the tower was a vertical timber weight tube, which formed a central support for a winding timber stair that climbed up the bottom three levels of the tower. On the fourth level, where the conical tower was too small to fit a stair, there was a fixed ladder up to the level of the light room and balcony.

The frame was supported at the bottom by a segmented cast iron ring that formed a base, bolted down to a massive concrete footing and floor cast within a low stone wall. The timber posts were bolted to lugs made as part of the iron ring.

The tower was clad with a covering of galvanised wrought iron plates, about 2.5 mm thick, which were rolled to the conical shape. Joints between the plates were lapped and riveted, and the plating was screwed to the timber framework and to the iron ring at the base. A timber door was fitted at the bottom of the tower, and glazed windows at each floor level.

At the top of the tower was a timber framed structure which formed the floor of the lantern room and the projecting balcony surrounding the lantern. This balcony floor had a flooring of timber boards with a waterproof covering of lead sheet. On this floor was assembled a hexagonal lantern room with a domed roof, all constructed by the building contractor – this was probably done to save the cost of an expensive imported prefabricated lantern. Inside the lantern was a typical Chance Brothers 4th order (250 mm focal radius) rotating optical apparatus with kerosene (paraffin) wick burner and weight-driven clockwork.

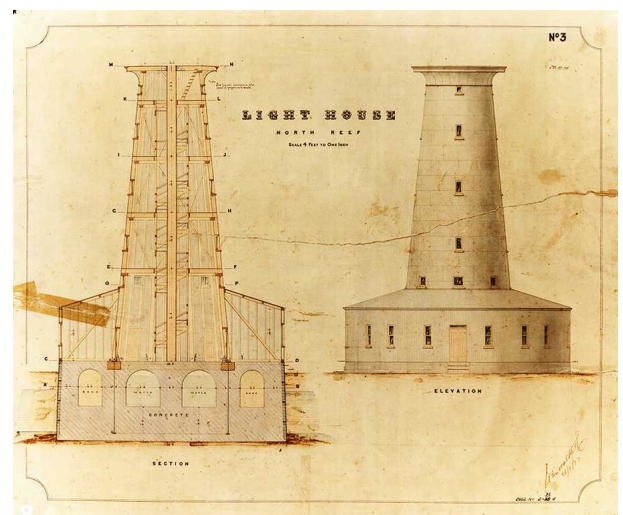
Figure 5. North Reef lighthouse, 1878

The tower sits on a cylindrical caisson of cast iron segments bolted together, sunk below low water onto a foundation of coral, and filled with concrete. This iron and concrete base is 13 m in diameter and 4.6 m high, with voids formed inside the mass of concrete for storage of fresh water. The tower was originally surrounded by the sand island, but the island later migrated away from the tower, leaving the lighthouse surrounded by water. It is now again surrounded by sand.

The 24 m high main tower was generally similar to that at Lady Elliot Island, but on a larger scale. There were four intermediate floor levels, and the optical apparatus was of the 2nd order. Apart from the iron and concrete base the most unusual aspect of the structure was the ring of rooms around the base of the tower. Here were the keepers' quarters, comprised of three bed rooms, two kitchens, two sitting rooms, and a store room – perhaps the head keeper had a private kitchen and sitting room, and the two assistant keepers had to share. The keepers quarters were framed and lined with timber, with a roof covering of galvanised iron with rolled seams, and external wall sheeting of corrugated galvanised iron.

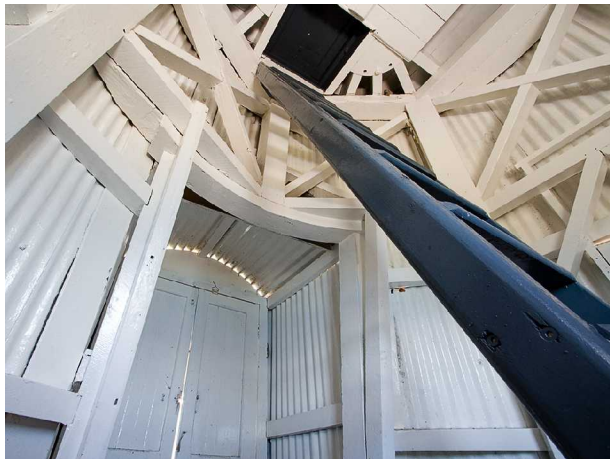
Figure 6. Interior of Goods Island lighthouse

In the 1880s a variant design was introduced for shorter towers, with corrugated galvanised iron sheeting instead of the thicker boiler plate. The first of this type was built at Goods Island in the Torres Strait. The timber framework had heavy timber cross bracing, but was otherwise similar to the iron plated type. The sheeting was specially formed with tapering corrugations to suit the conical shape of the tower.
