3rd Australasian Engineering Heritage Conference 2009

Queensland's timber and iron lighthouses: 19th century colonial innovation.

Peter Marquis-Kyle, conservation architect, Brisbane

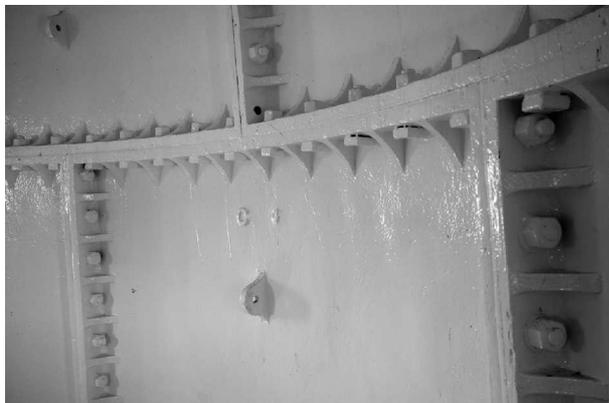
Figure 2. The cast iron plates of the Bustard Head lighthouse tower

The two cast iron lighthouses were erected by private building contractors under the supervision of officers of the Department of Public Works and with the advice of the Portmaster. The contractors also built timber houses for the light keepers. Erecting the iron lighthouses was quick, but getting the lighthouse components and other materials to the sites and preparing concrete bases beforehand took many months. The departmental staff and the contractors learned some useful lessons about the best ways to organise the works – lessons they would later apply to other lighthouse projects.

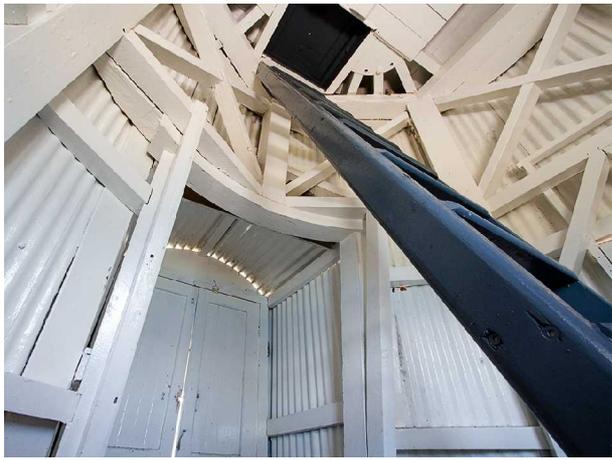
Figure 6. Interior of Goods Island lighthouse

In the 1880s a variant design was introduced for shorter towers, with corrugated galvanised iron sheeting instead of the thicker boiler plate. The first of this type was built at Goods Island in the Torres Strait. The timber framework had heavy timber cross bracing, but was otherwise similar to the iron plated type. The sheeting was specially formed with tapering corrugations to suit the conical shape of the tower.
