# A UNIQUE COMPLEX

The Arts Centre of Christchurch is one of the most important heritage sites in New Zealand. Its complex of High Victorian Collegiate Gothic buildings occupies a five-and-a-half acre (about 2.25 hectare) central city block and is the largest collection of this style of heritage structure in the Southern Hemisphere. All 23 Category 1 heritage buildings on the site suffered significant levels of damage in the series of earthquakes since September 2010.

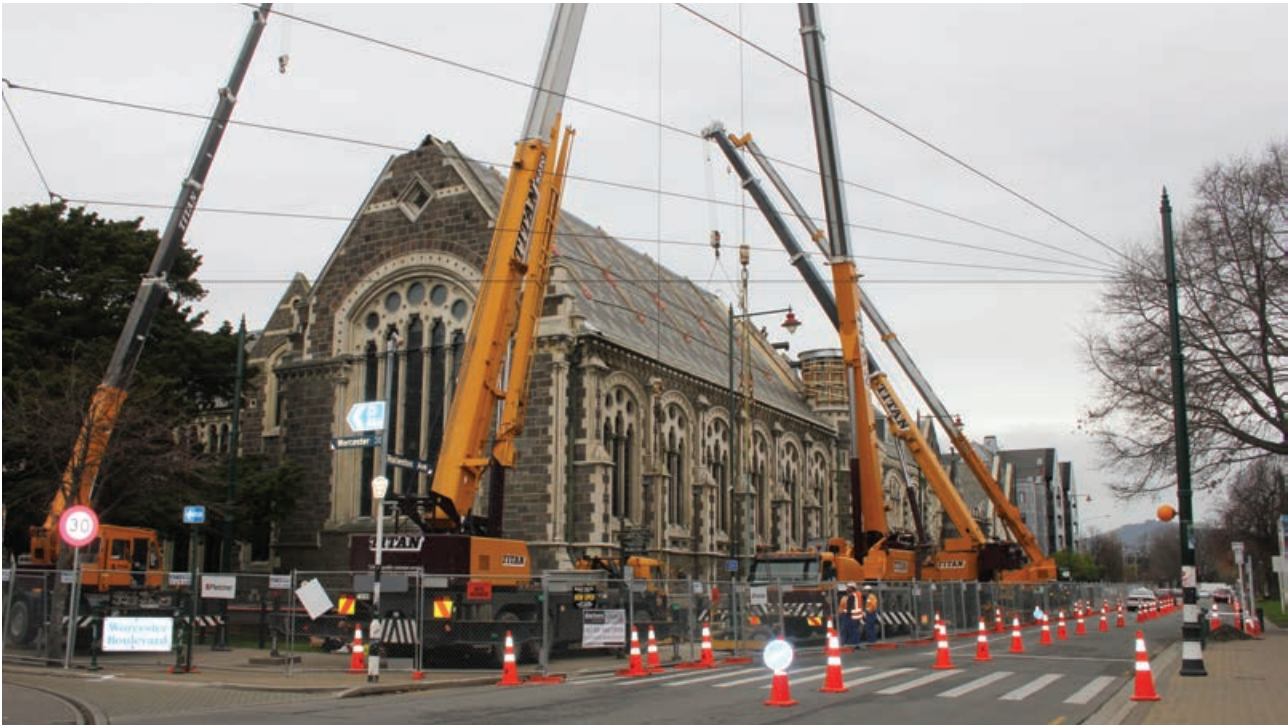
*The College Hall from the corner of Worcester Boulevard and Rolleston Avenue: steel frames and post-tensioned rods secure the north and south gables from possible collapse. Image courtesy of Liz Hodgson, Christchurch Arts Centre.*

As consultant engineers to the Arts Centre over the past 20 years, the Holmes Group previously completed important securing works across the site and some limited additional seismic strengthening works. Securing works such as large steel rosettes and steel tensioned rods are obvious in many exterior elevations.
