# Wilsons Dam: Design expectations compared with measured performance

*Wilsons Dam is an 18 m high, zoned earthfill water-supply dam, constructed for the Whangarei District Council to supplement the Bream Bay supply. The dam is located on the Waiwarawara Stream close to State Highway One at Ruakaka. The stream catchment area is relatively small (3.9 km<sup>2</sup>) and a viable water supply in the Northland climate required seepage losses to be minimised. The valley floor comprises a 15 m deep sequence of soft alluvial silts and clays interbedded with permeable sand and gravel lenses.*

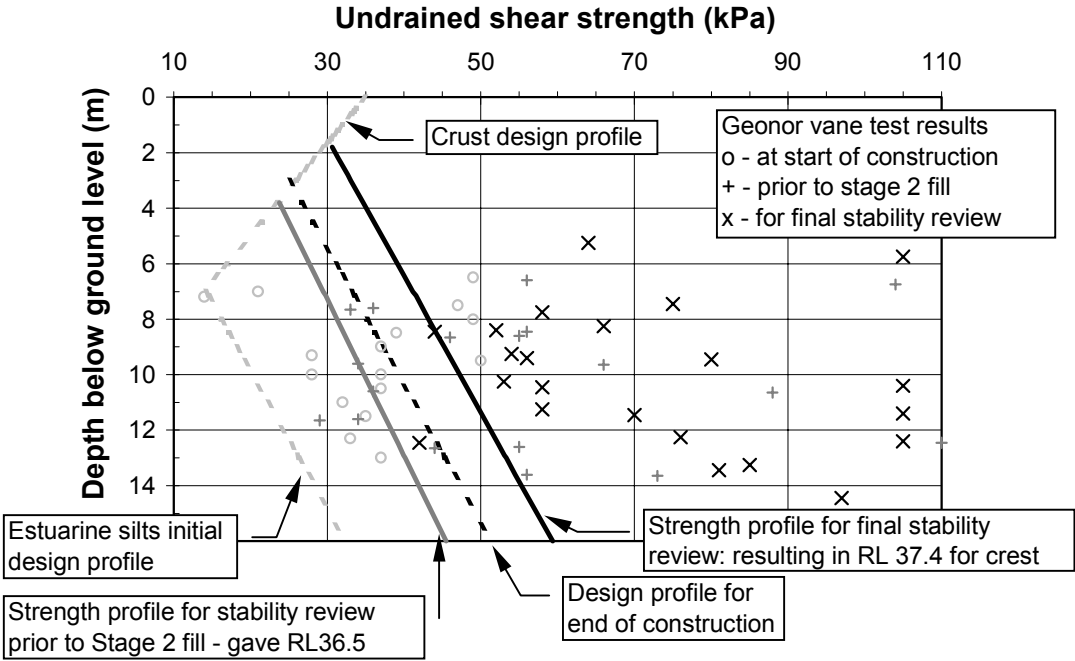
Figure 3. Shear strength profiles.

An undrained shear strength profile, based on the work of Leroueil et al. (1990), was developed for the design. Gains in shear strength resulting from consolidation were predicted using the increase in effective stress resulting from dam fill. During construction, strength gains in the foundation were measured using 'Geonor' shear vane tests. The predicted 'design' strength profiles are shown in Figure 3 and compared with test data and interpreted 'reasonable lower bound' strength profiles used for stability review. The comparison demonstrates that, while there was significant scatter in the test results, trends in actual strength gain were reasonably approximated by the design profiles.

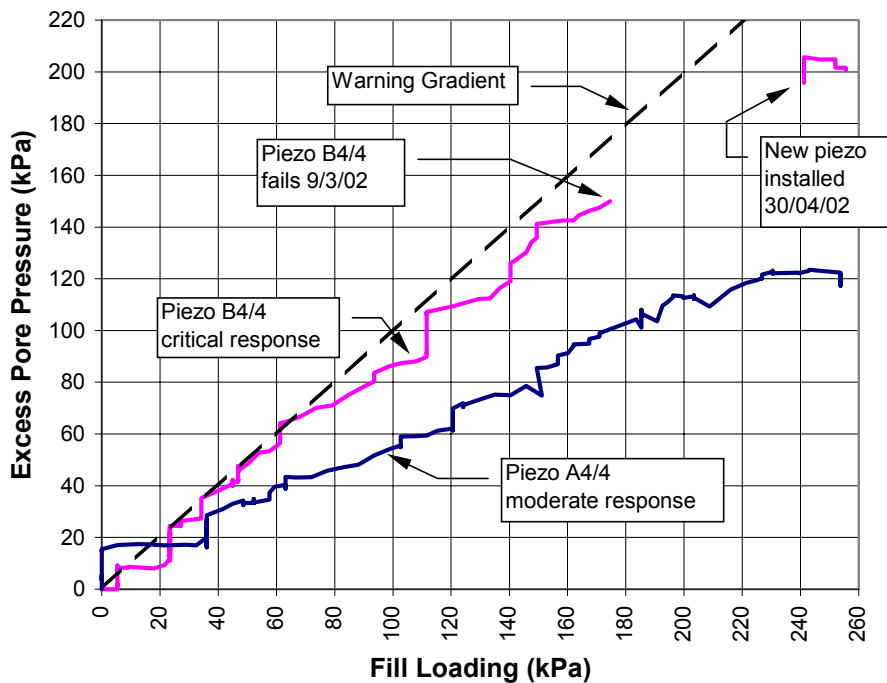
Figure 4. Foundation pore-pressure response monitoring.

When normally consolidated soils are loaded in undrained conditions, pore pressures increase proportionally with load. However, as loading continues the soil will eventually begin to yield, at which point the excess pore pressure rises at a rate greater than the applied load. Routine monitoring of fill rates was achieved by plotting pore pressure rise in the foundation piezometers vs estimated fill load, as shown by sample traces from two instruments in Figure 4. Both the piezometers plotted are located approximately 8 m upstream of the dam centreline and at the mid-layer depth in the 'estuarine silts'. The contract conditions included provisions to suspend filling if pore pressures were judged to be excessive. However, in the reality of the 2001 earthworks seasons, this option was not exercised and fill rates were effectively constrained by weather.

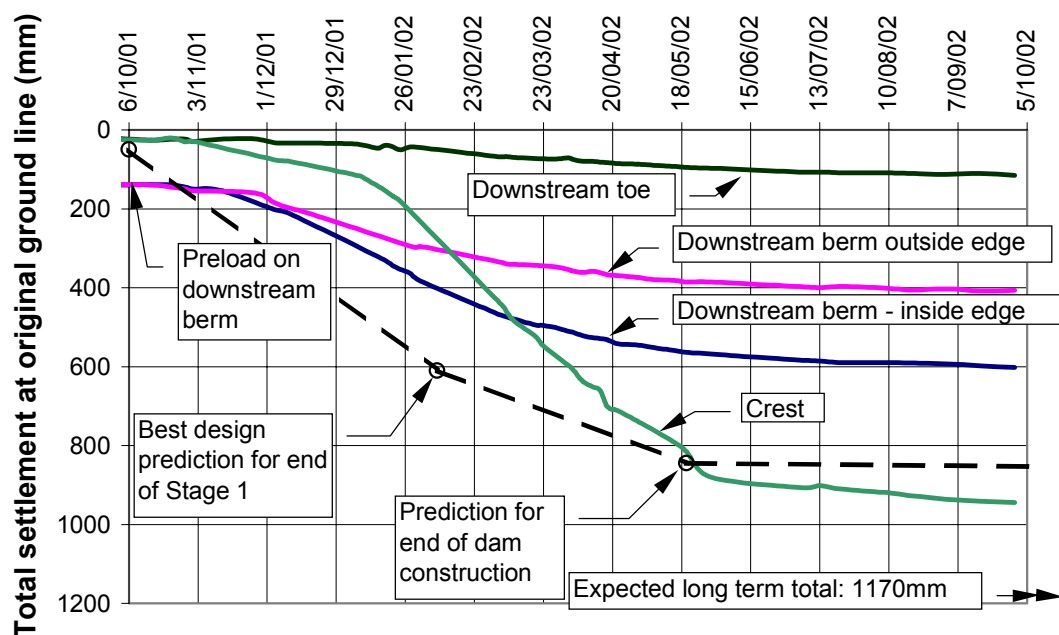
**Figure 5. Measured foundation settlements, mid-valley.**

Results of settlement measurement at the crest and other key locations are shown in Figure 5 and indicate a high degree of conformity with the original predictions.

Settlement during construction depends on the response of the foundation soils under load and the efficiency of the wick drainage. Expectations were that the degree of consolidation would be at least 50% and possibly 75% by the end of construction. Settlement predictions during construction were thus in a range of 570–845 mm. By the end of construction, settlement had reached 900 mm as measured by magnetic extensometer probe under the crest. Assessments of actual consolidation by the end of construction were higher than expected with a degree of consolidation at 80–90%, as a result of the extended duration for fill placement.

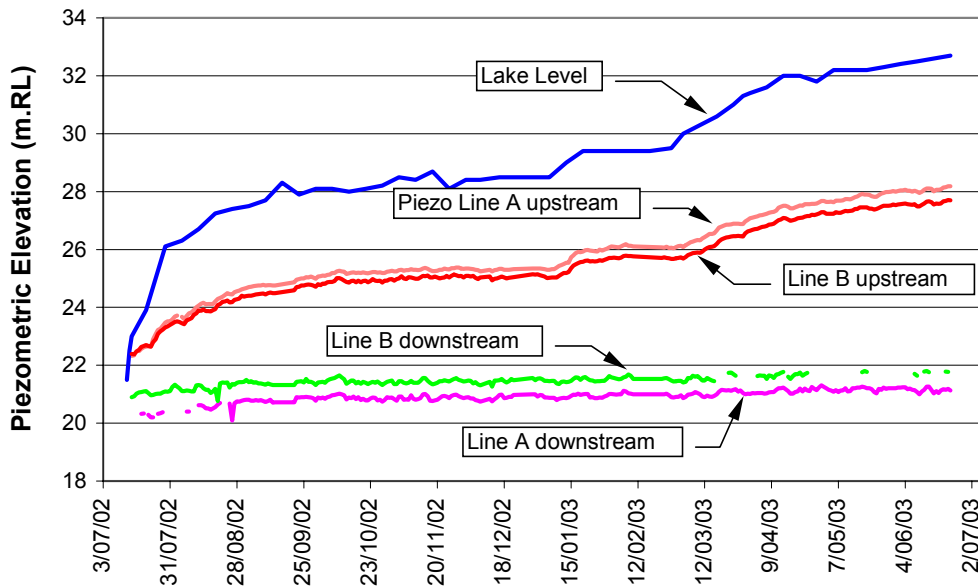
Figure 6. Head loss across slurry cut-off wall.

The cut-off wall was specified as a very weak cement-bentonite slurry with requirements on plasticity, permeability and a 28 day unconfined compressive strength of 150 kPa. The mix design and installation techniques were developed by Australian consultants, M.P.A. Williams and Associates. Roadstone planned and managed the construction with assistance from Richardson Drilling for slurry mixing. Installation was achieved with local resources. MWH set trench target depths based on a series of CPT’s along the dam centreline and construction was monitored closely to ensure that the wall extended into the ‘estuarine silts’. Some problems of trench collapse occurred, where gravel deposits were thicker and close to the surface. However, initial concerns that these collapses would bridge the trench have been allayed by comparison of piezometer records (see Figure 6) between Line B where trench collapse occurred and Line A where the trench stayed intact.

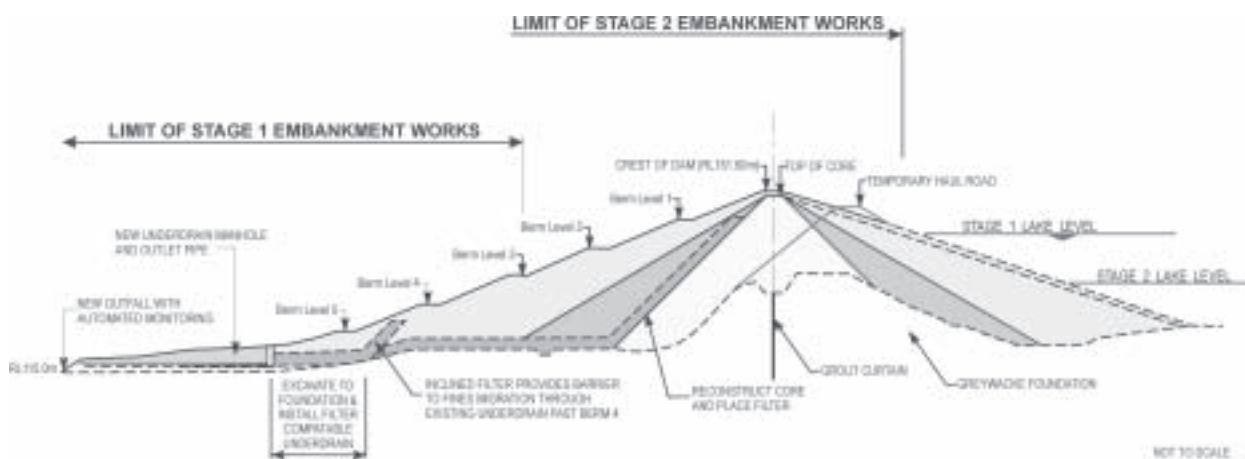
URS NZ Ltd were retained to carry out the detailed design in February 2001. The key features of the upgrade design (Figure 2) were:

Figure 2. Section through Cosseys Dam, near Papakura, Auckland, showing construction stages for upgrade.

- Replacing the underdrain beneath the core of the dam with compacted core material where accessible and grout to seal the remaining underdrain that was not accessible;
- Reconstructing the underdrain with filtered drain material below the shoulder of the dam, downstream of the reconstructed core;
- Placing an inclined chimney drain/filter across the reconstructed core and abutments to provide filter protection and control ongoing seepage flows into the underdrain;
- Reconstructing the downstream shoulder of the dam and crest roadway; and
- Strengthening the valve tower to resist the appropriate seismic loads by anchoring into the rock abutments.

The project was divided into two distinct construction stages (Figure 2), each to be undertaken in consecutive construction seasons. A single construction contract was awarded for both stages. The contract was awarded in October 2001 and the work commenced on the replacement of the old single carriageway bridge over the Wairoa River on the only viable access road to the site in November. A replacement bridge and upgrading of the access through the private right of way and internal roads was undertaken at the start of Stage 1 to provide access for the plant and vehicles required for construction.

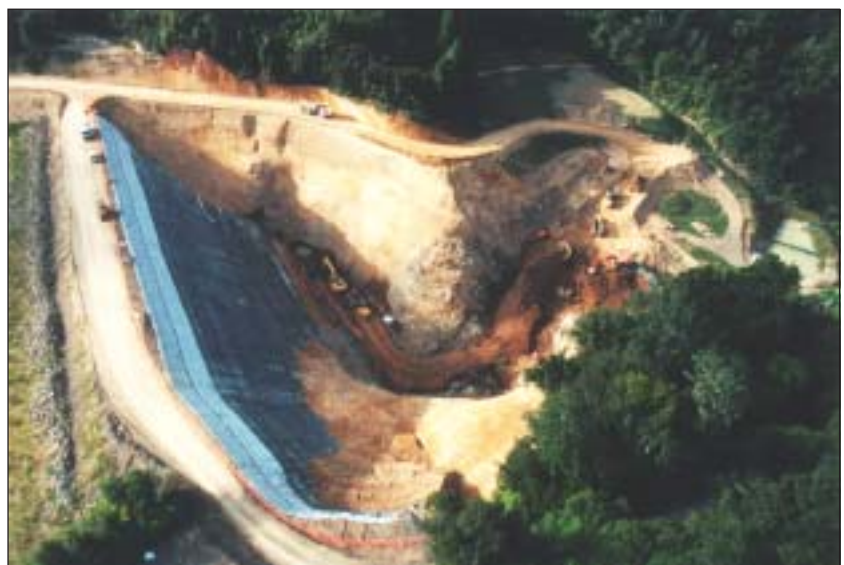
*Figure 3. Cosseys Dam with the face removed to allow the installation of the underdrain and filter.*

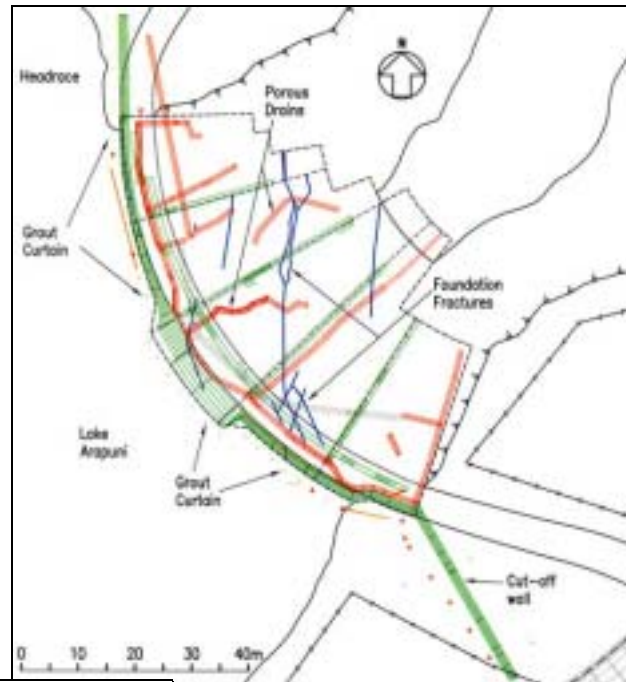
The 'no-fines concrete' porous drain network (Figure 2) is the main uplift control at the dam/foundation interface. The underdrain includes a continuous drain, known as the circumferential drain, sited parallel to, and immediately downstream of, the upstream cut-off wall. The 600 mm high × 600 mm wide circumferential drain has radial porous drains discharging seepage water to the downstream toe, where seepage is measured at V-notch weirs.

Figure 2. Plan view of Arapuni Dam. The positions of the foundation fractures noted during construction are shown. The diversion tunnel curves to the south of the right abutment cut-off wall.

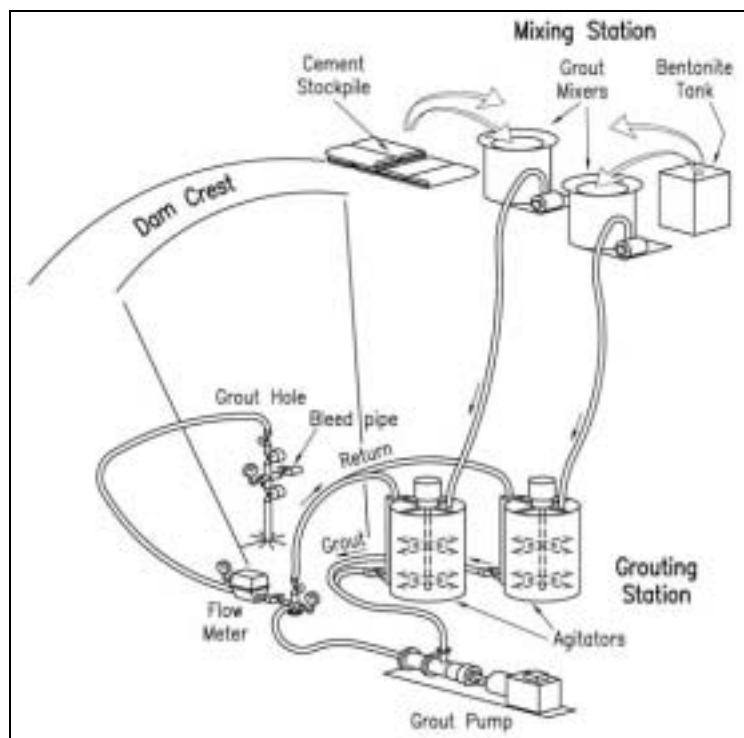
The setup of grouting equipment is shown on Figure 5, with the grout mixing station at dam crest level on the left abutment and the grout injection station at the toe of the dam.

Figure 5. Grout equipment layout at Arapuni Dam.
